# Oregon State University Utility Pole Research Cooperative

31st Annual Report  
October 3<sup>rd</sup> 2011

### **DEVELOP SAFER CHEMICALS FOR CONTROLLING INTERNAL DECAY OF WOOD POLES**

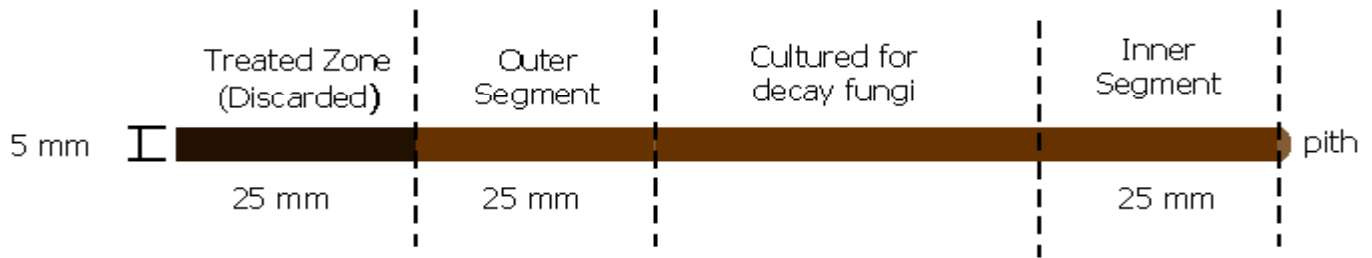
Figure I-1. Representation of increment core showing inner and outer 25 mm segments analyzed for fumigant content. The length of the segment cultured for decay fungi varies in length depending on the size of the pole.

MITC distribution was assessed 1, 2, 3 and 5 years after treatment by removing increment cores from three locations around the pole 150 mm below groundline, at groundline as well as 300, 450 and 600 mm above groundline. The treated zone of the core was removed and then the inner and outer 25 mm of each core were placed in ethyl acetate, extracted for 48 hours at room temperature and then the extract was removed and analyzed by gas chromatography for MITC. The remainder of each core was placed on 1.5 % malt extract agar and observed for evidence of fungal

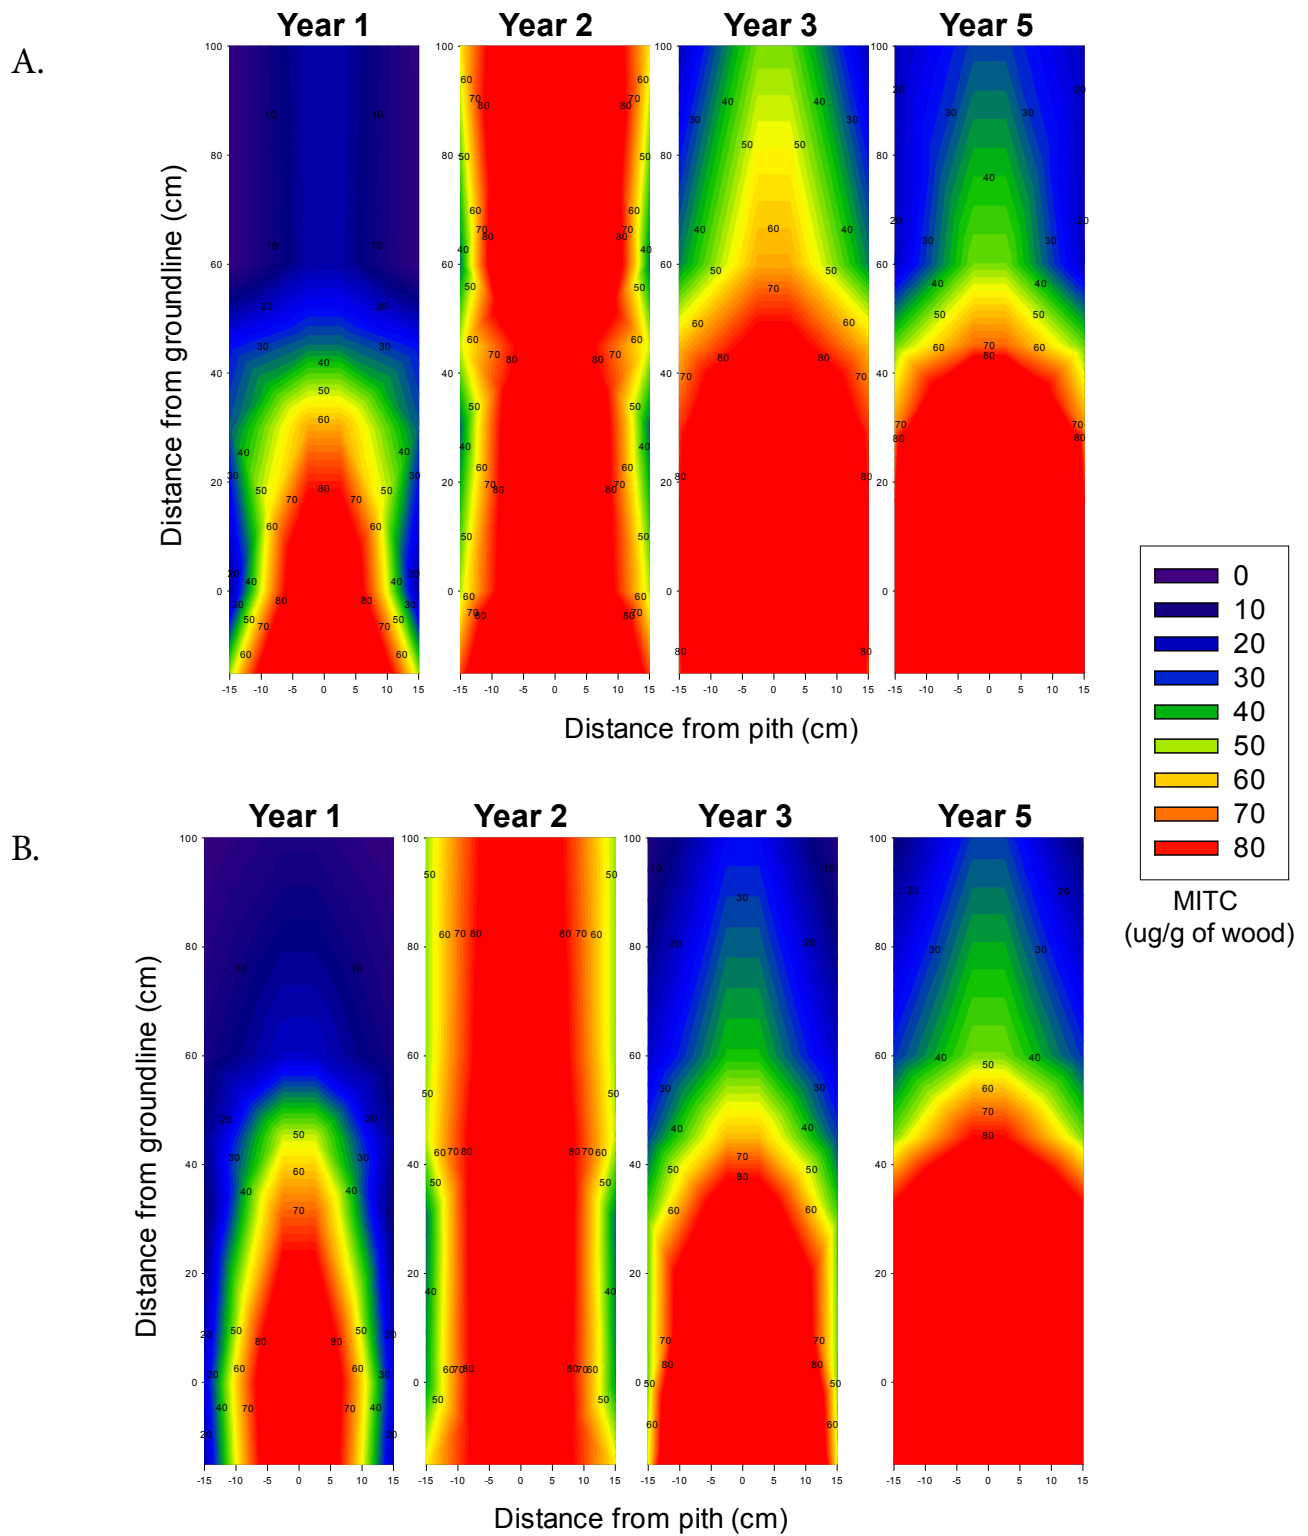
Figure I-2. Maps showing relative levels of MITC in Douglas-fir poles 1 to 5 years after treatment with A. granular dazomet alone or B. the same system in paper tubes.

MITC levels in poles receiving any of the dazomet treatments were above the 20 ug threshold within one year after treatment between 150 mm below groundline and 450 mm above that zone. MITC levels were slightly more variable 600 mm and 900 mm above groundline (Table I-2, Figures I-2-3). The use of a copper naphthenate accelerant had little effect on total MITC levels found in the wood. This contradicts previous studies showing that the presence of copper enhanced dazomet decomposition to MITC. It is unclear why the copper had so little effect, although moisture levels in the wood may have naturally accelerated decomposition thereby negating the value of the copper. There also appeared to be little difference in MITC levels in poles receiving granular dazomet alone or applied in paper tubes. These results indicate that the paper did not interfere with either dazomet decomposition or subsequent MITC diffusion into the wood. Table I-2a. MITC levels in Douglas-fir poles 1 to 5 years after application of dazomet as a granular formulation or in paper or plastic tubes as measured 150 mm below to 300 mm above the groundline.

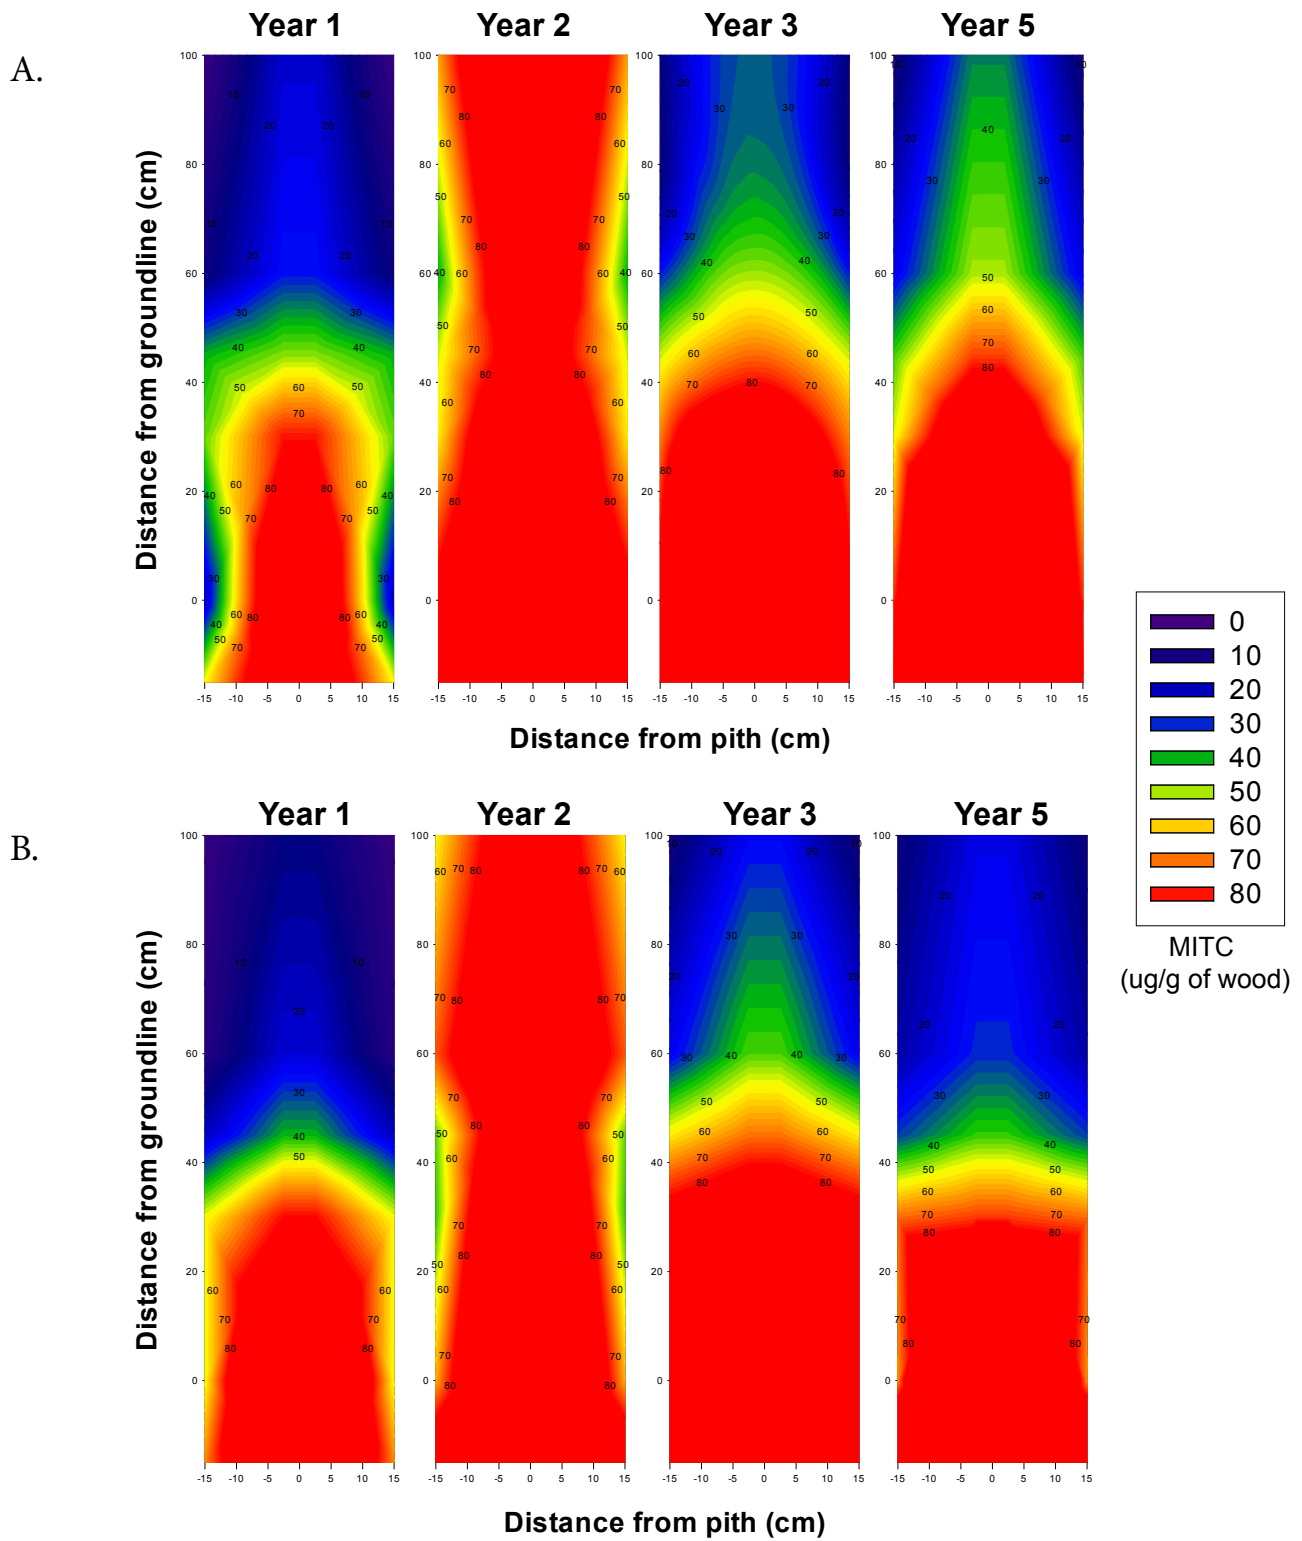
Figure I-3. Maps showing the effects of copper naphthenate addition on relative levels of MITC in Douglas-fir poles 1 to 5 years after treatment with A. granular dazomet alone or B. the same system in paper tubes.

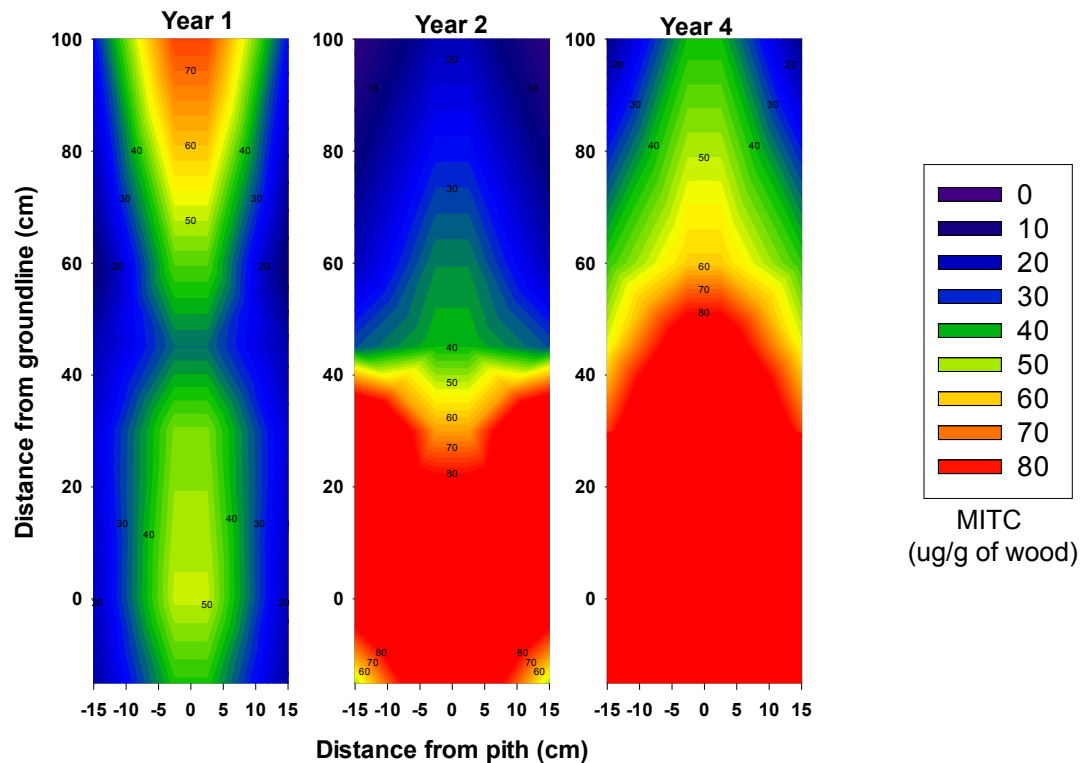
Figure I-4. Maps showing relative levels of MITC in Douglas-fir poles 1 to 4 years after treatment with granular dazomet in plastic tubes.

The use of a plastic tube to contain the dazomet prior to application initially appeared to have a negative effect on MITC levels in the surrounding in wood (Figure I-4). While MITC levels did reach the threshold in the first year, the levels in the -150 mm to +300 mm zone have yet to reach those found in the poles receiving dazomet granules or tubes. This suggests that the plastic tubes may be less useful for this application, although they may have other attributes that make them easier to transport or apply.

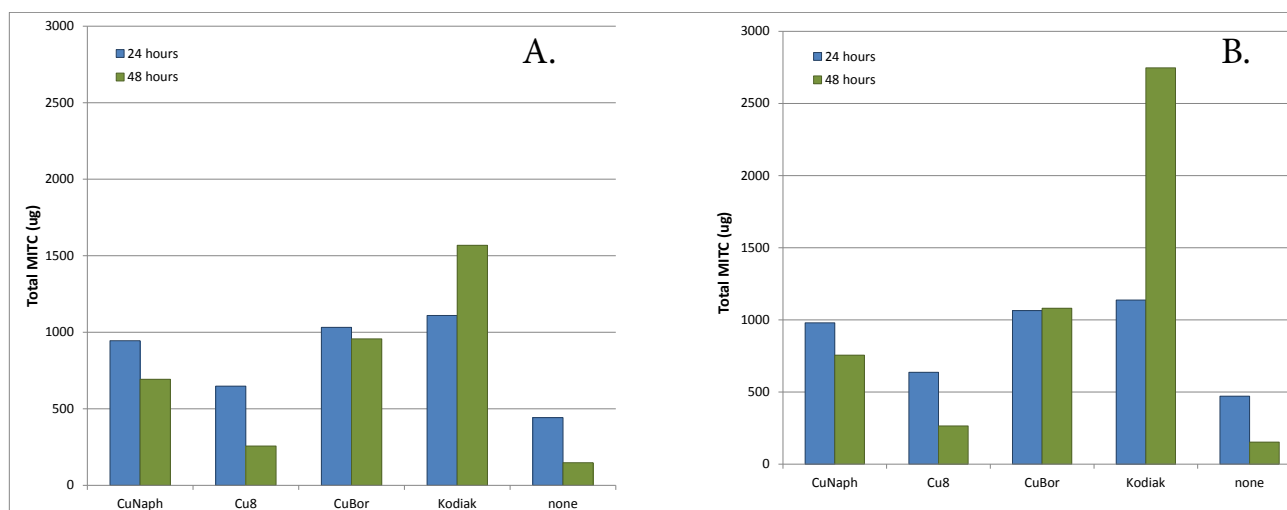
Figure I-5. Effect of accelerants and moisture content on release of MITC from dazomet mixed with Douglas-fir heartwood A. dry and B. at 50% MC and incubated at room temperature for 24 or 48 hours.

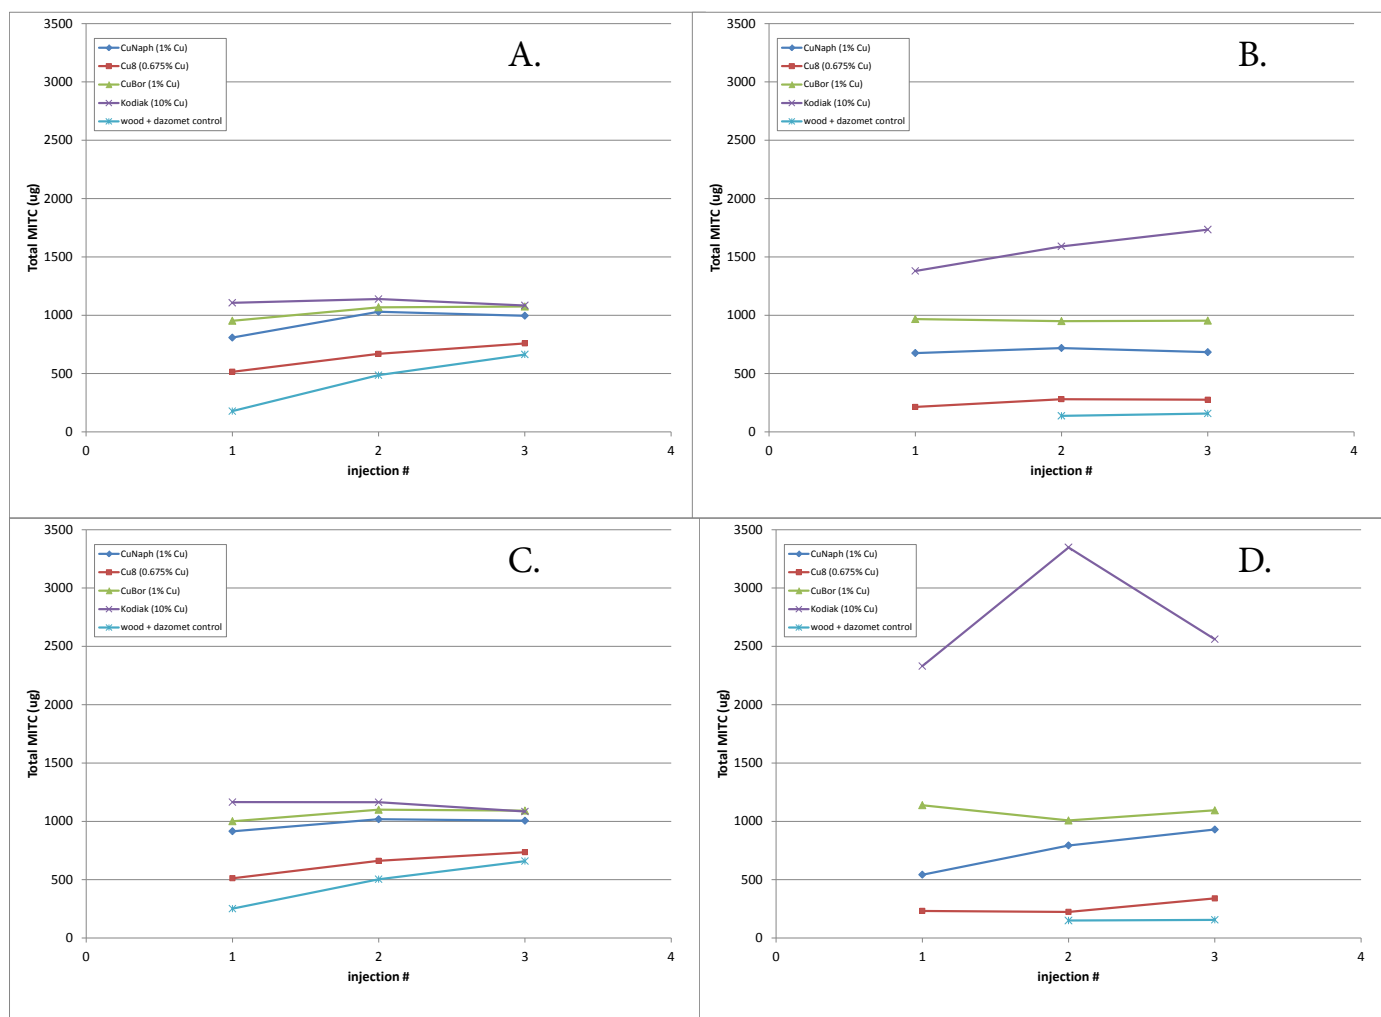
Figure I-6. MITC levels in replicate ethyl acetate extracts from vials containing dry A. 24 hour and B. 48 hour or wet C. 24 hour and D. 48 hour Douglas-fir sawdust with dazomet, and with or without an accelerant. The three injections were approximately 60 minutes apart.

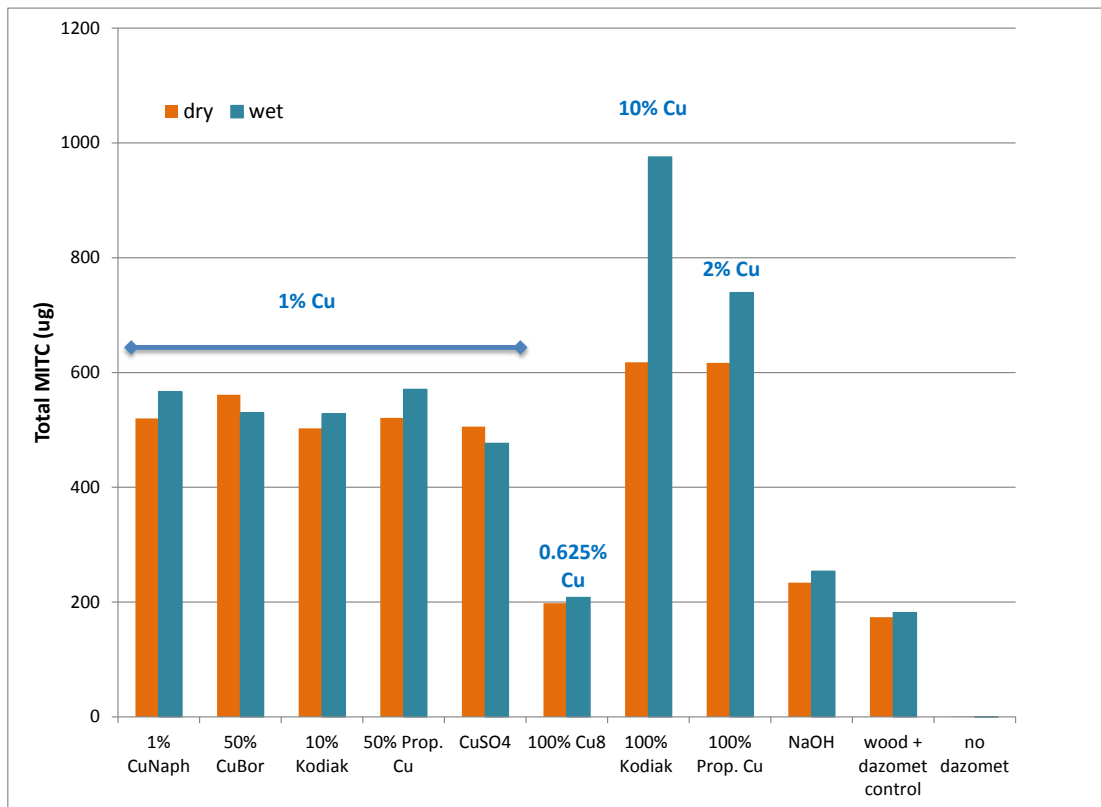
Figure I-7. Effect of accelerants on dazomet decomposition to MITC in the presence of ground Douglas-fir wood and water.

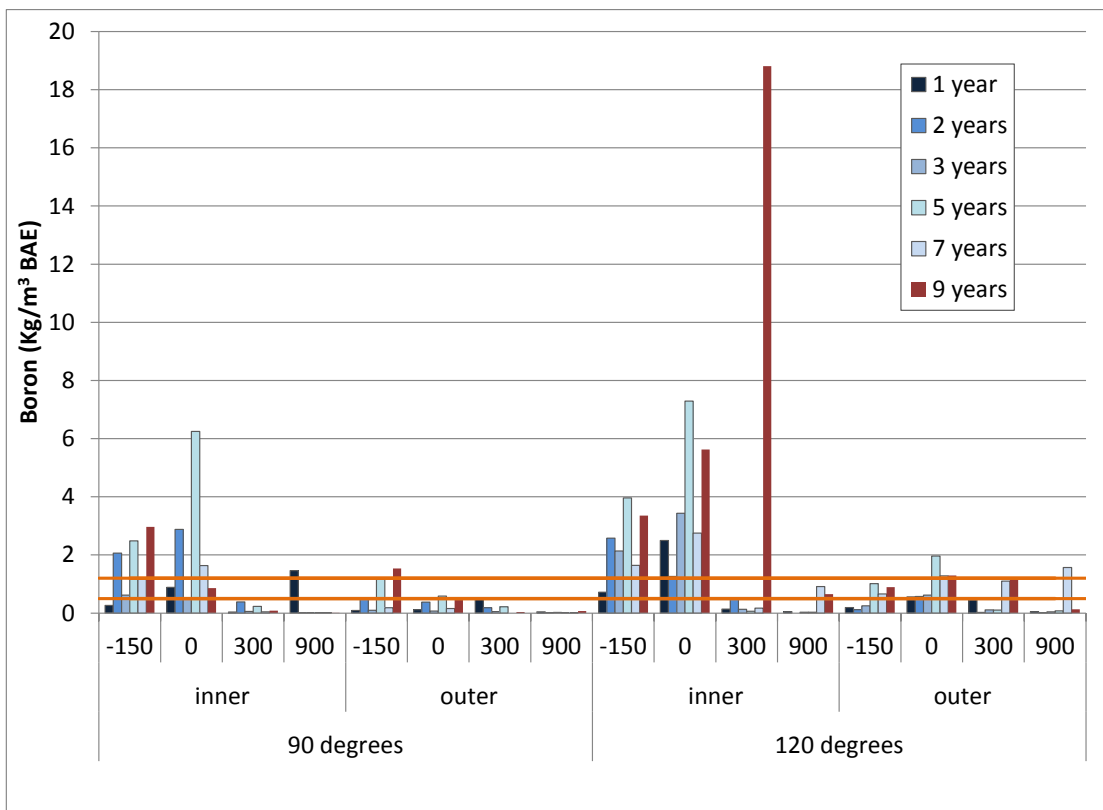
Figure I-8. Boron levels at selected locations above or below groundline in Douglas-fir poles 9 years after treatment with 4 boron/copper rods.

Boron levels in pole sections were below the protective threshold level 1 year after treatment, but then gradually increased over the threshold in the next 2 years (Figures I-8 & I-9). Treatment levels appeared to drop slightly between 5 and 7 years after treatment, although they remained above the threshold in many cases. Boron levels tended to be highest at groundline and 150 mm below that zone, reflecting the tendency for the wood to be wetter in these regions. Moisture is

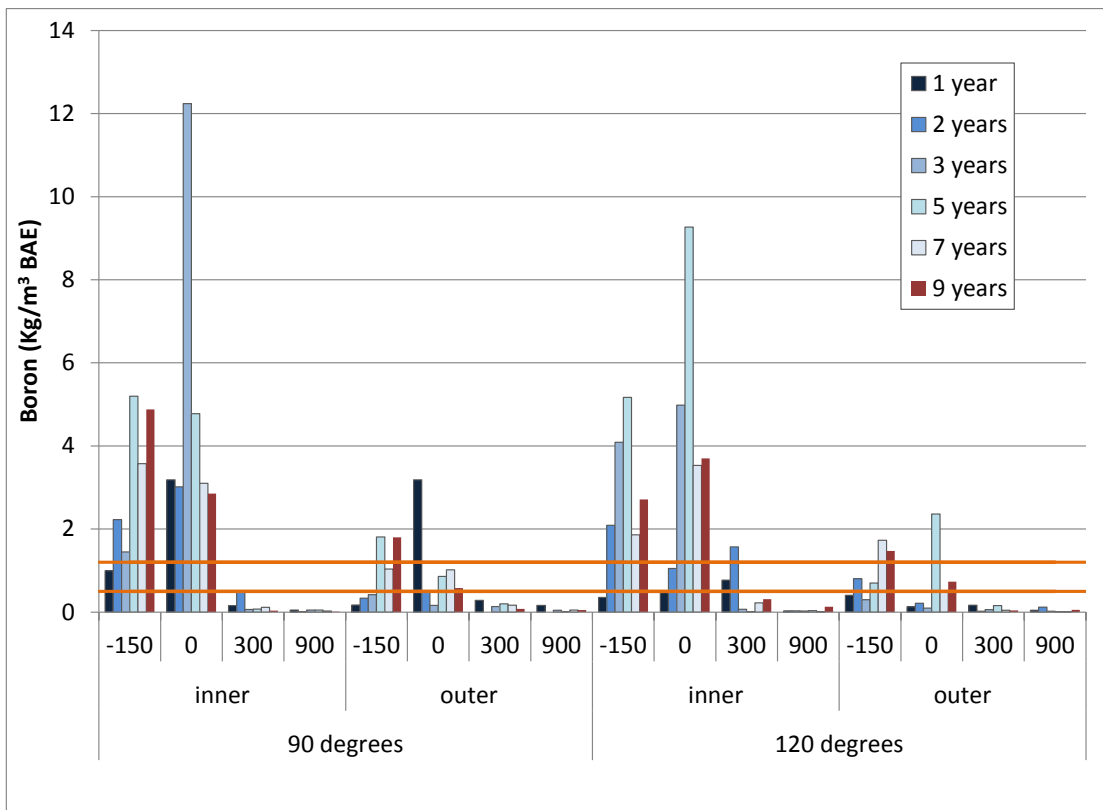
Figure I-9. Boron levels at selected locations above or below groundline in Douglas-fir poles 9 years after treatment with 4 boron rods.

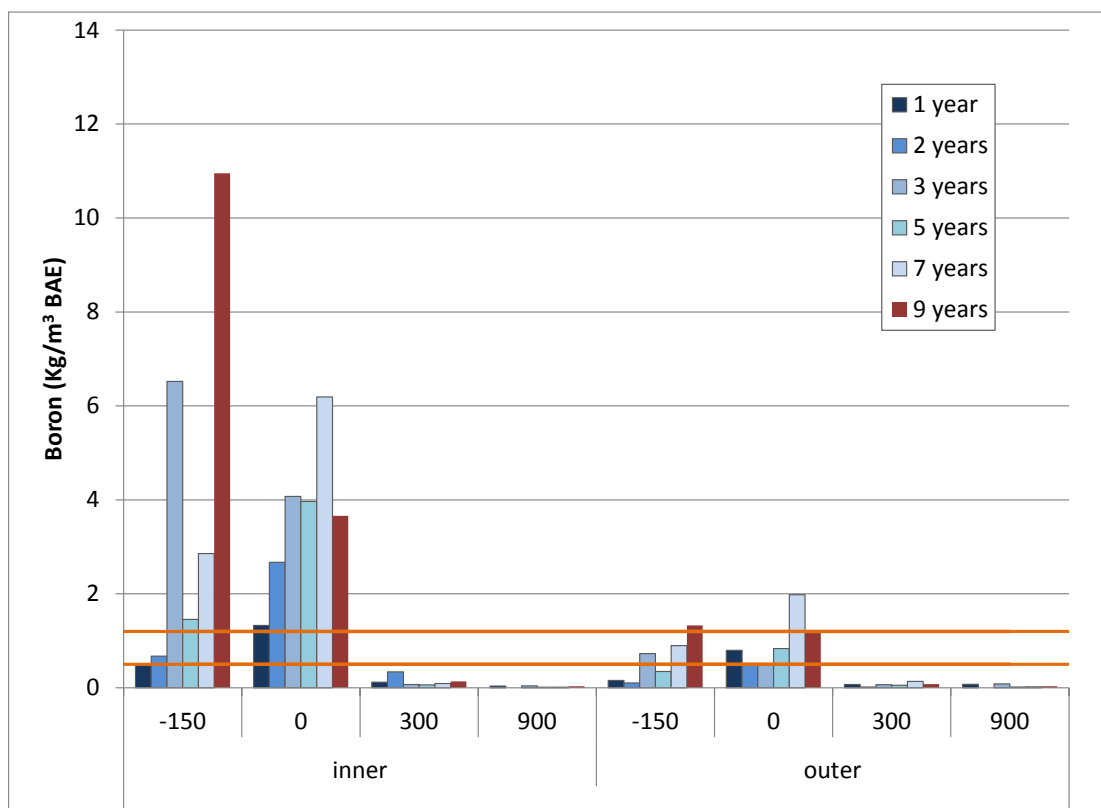
Figure I-10. Boron levels at selected locations above or below groundline in Douglas-fir poles 9 years after treatment with 8 boron/copper rods.

Increasing the rod dosage from 4 to 8 rods per pole had only a slight effect on borate levels in the wood (Figure I-10). While boron levels in the wood did not double with the higher dosage, they did increase somewhat in the inner zone. More importantly, they appeared to be slightly more stable in terms of levels over time. Boron levels in the outer zone tended to be low over the entire test period. While there was some indication that boron levels might be slightly higher in the

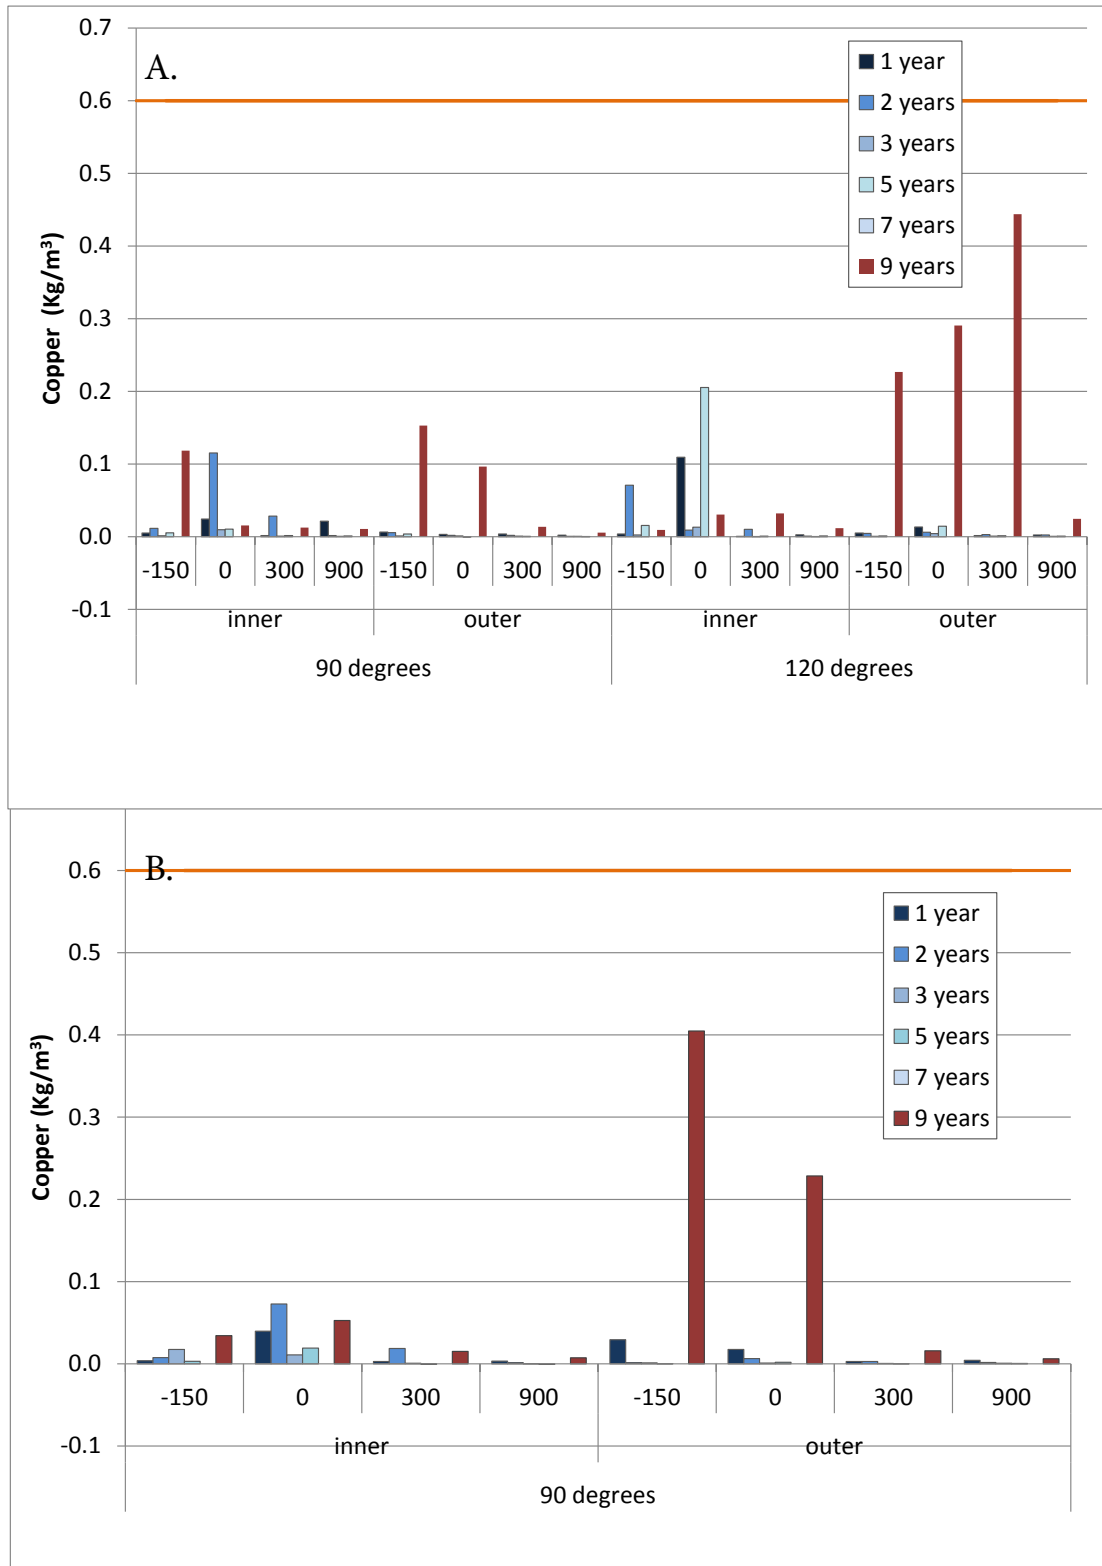
Figure I-11. Copper levels at selected locations above or below groundline in Douglas-fir poles 9 years after treatment with A. 4 or B. 8 boron/copper rods.

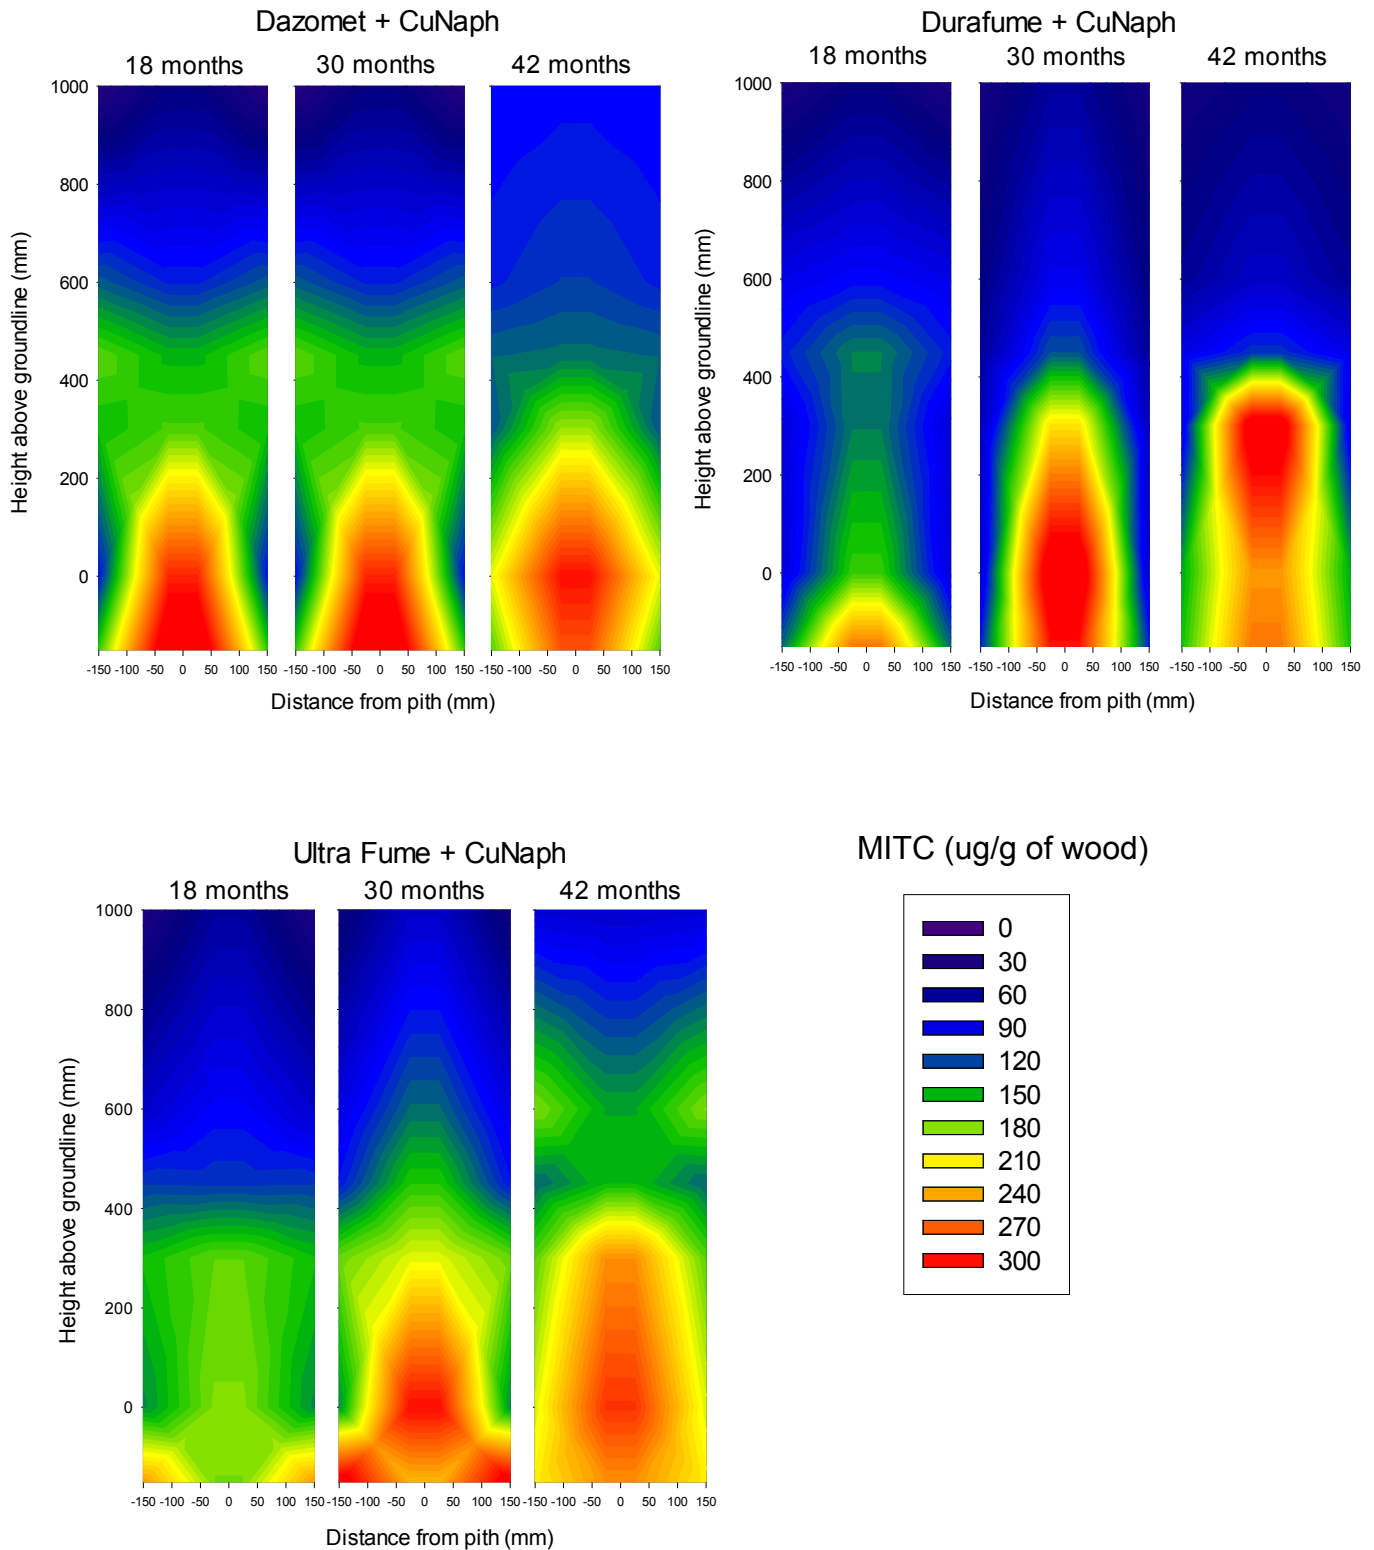
Figure I-12. Distribution of MITC in Douglas-fir poles sections 18 to 42 months after treatment with dazomet plus copper naphthenate, DuraFume plus copper naphthenate or UltraFume plus copper naphthenate.

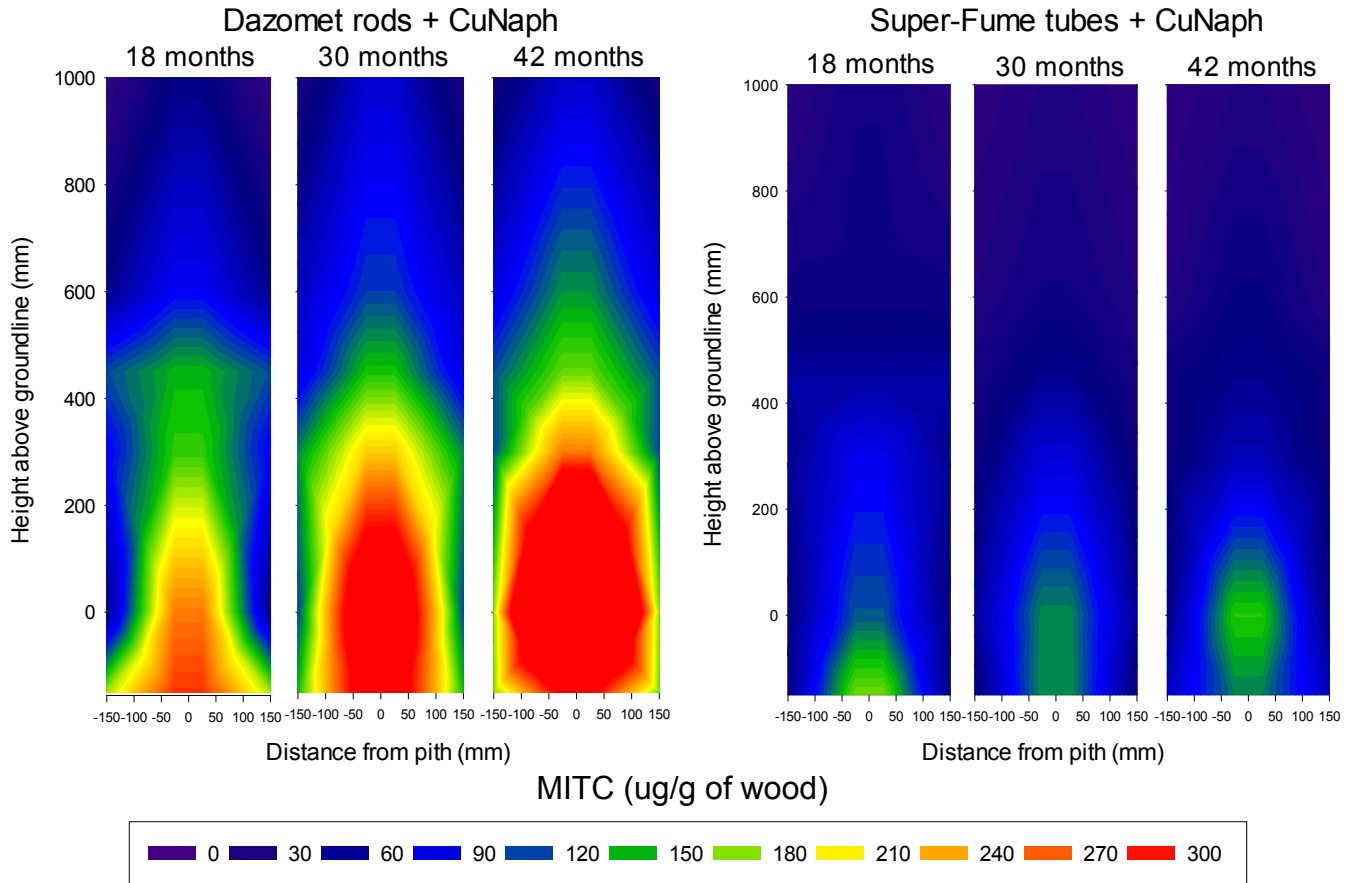
Figure I-13. Distribution of MITC in Douglas-fir poles sections 18 to 42 months after treatment with dazomet rods plus copper naphthenate or Super-Fume tubes plus copper naphthenate.

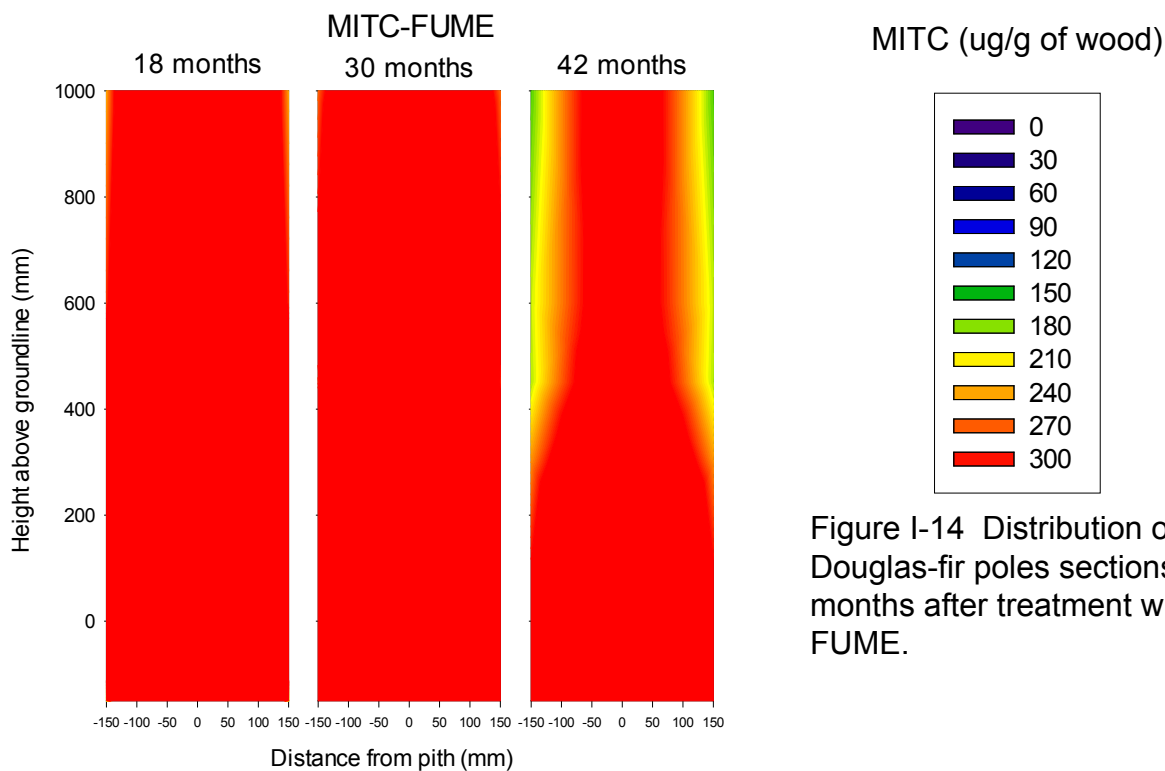
Figure I-14 Distribution of MITC in Douglas-fir poles sections 18 to 42 months after treatment with MITC-FUME.

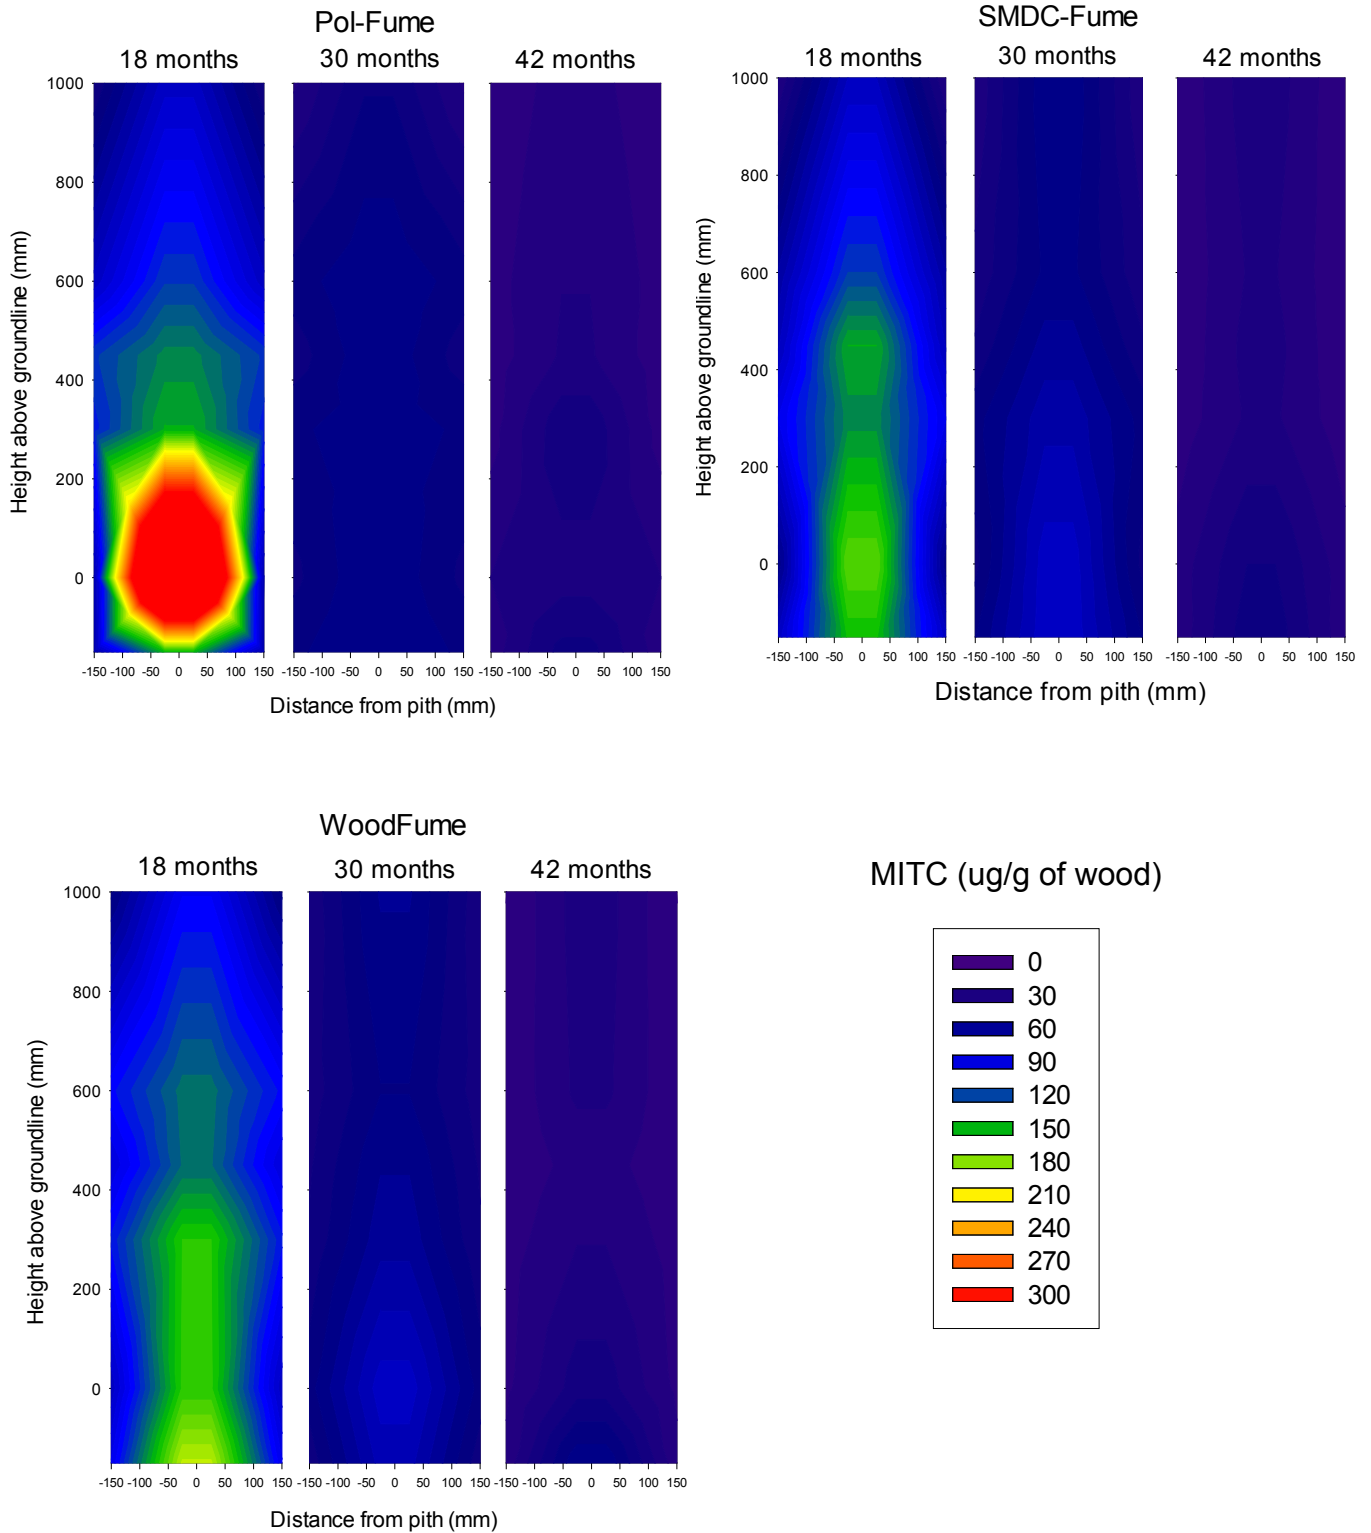
Figure I-15. Distribution of MITC in Douglas-fir poles sections 18 to 42 months after treatment with Pol-Fume, SMDC-Fume, or WoodFume.

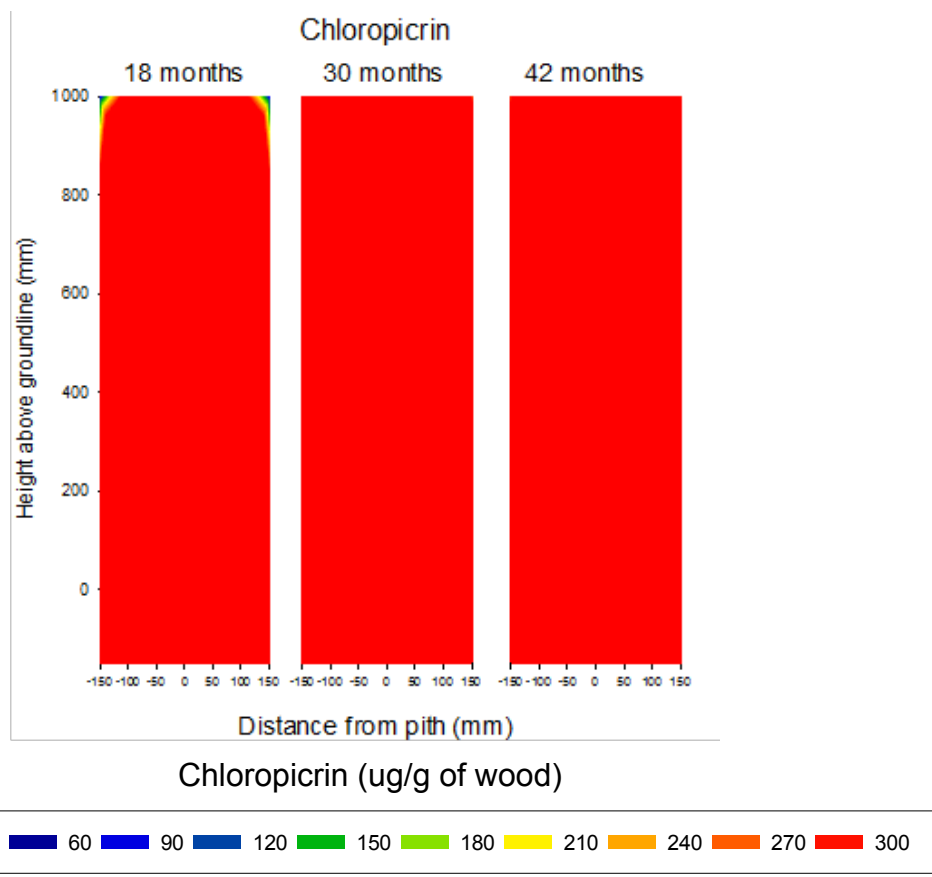
Figure I-16 Distribution of chloropicrin in Douglas-fir poles sections 18 to 30 months after treatment.

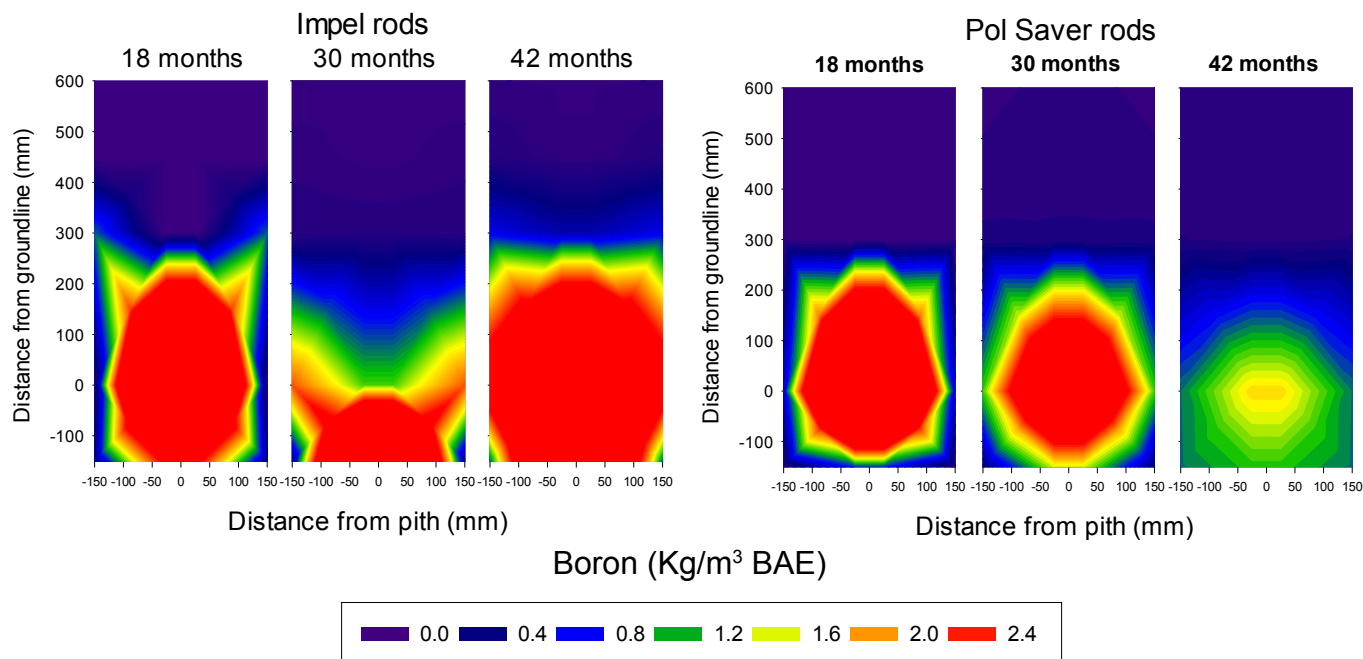
Figure I-17. Boron distribution in Douglas-fir poles 18 to 42 months after application of Impel or Pol Saver rods.

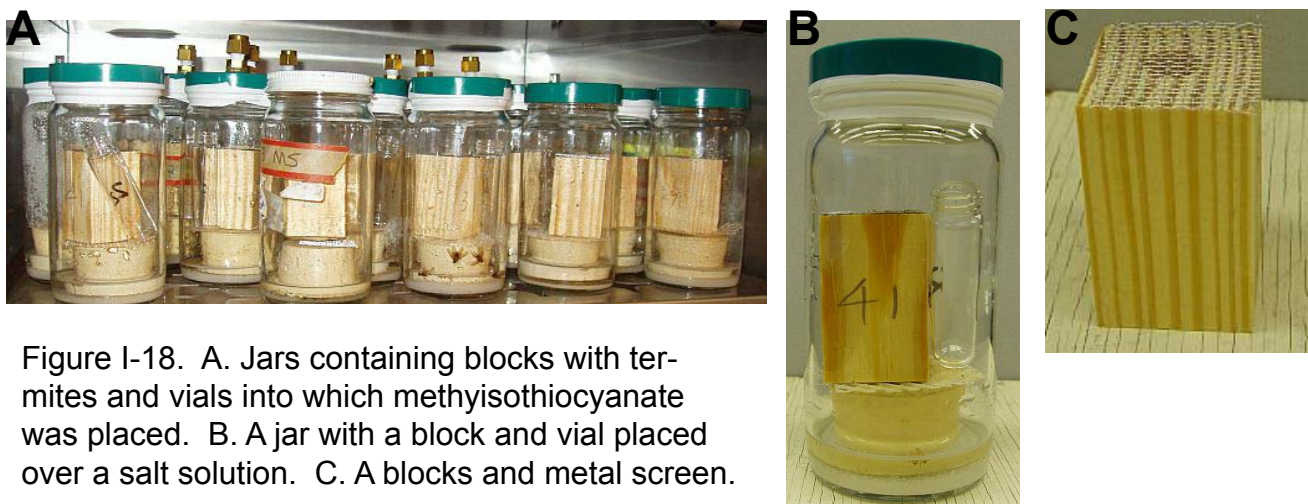
Figure I-18. A. Jars containing blocks with termites and vials into which methylisothiocyanate was placed. B. A jar with a block and vial placed over a salt solution. C. A blocks and metal screen.
