# Oregon State University Utility Pole Research Cooperative

31st Annual Report  
October 3<sup>rd</sup> 2011

### **DEVELOP SAFER CHEMICALS FOR CONTROLLING INTERNAL DECAY OF WOOD POLES**

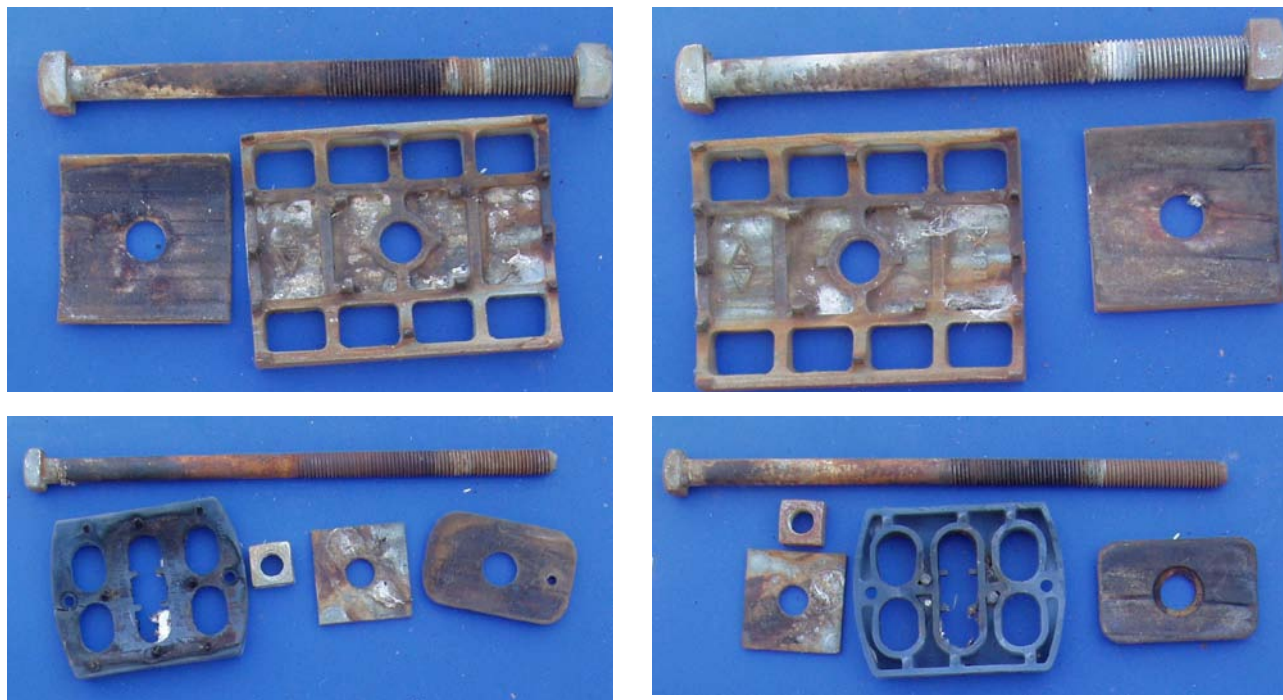
Figure II-1. Condition of nuts, bolts and gain plates removed from field drilled bolt holes 32 years after treatment of the exposed non-treated wood with ammonium bifluoride prior to bolt insertion.

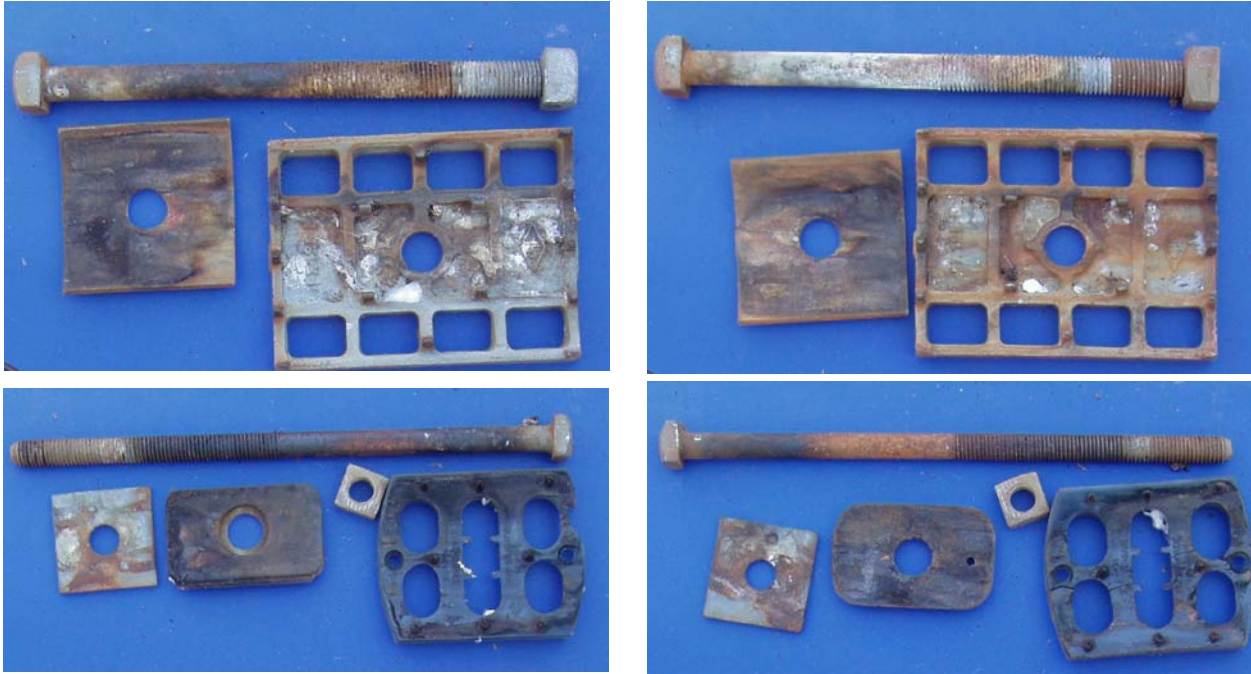
Figure II-2. Condition of nuts, bolts and gain plates removed from field drilled bolt holes 32 years after treatment of the exposed non-treated wood with boron (Polybor) prior to bolt insertion.

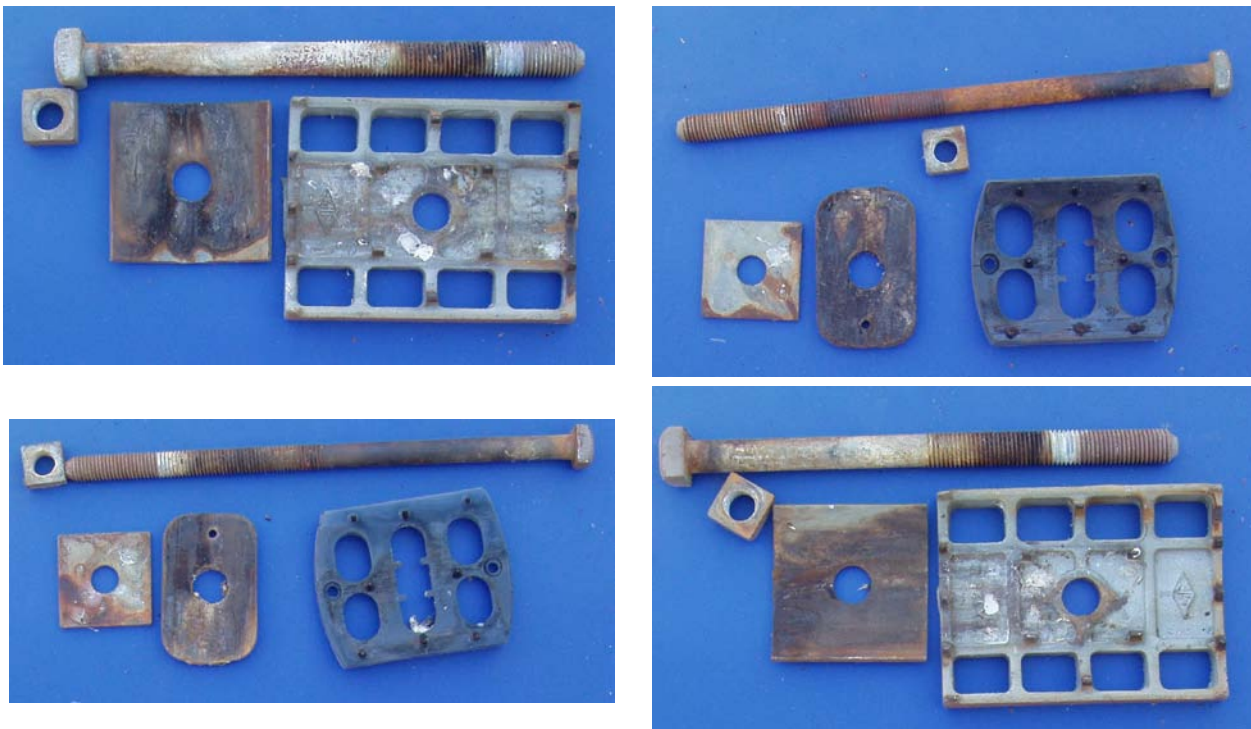
Figure II-3. Condition of nuts, bolts and gain plates removed from field drilled bolts holes 32 years after treatment of the exposed non-treated wood with Boracol prior to bolt insertion.

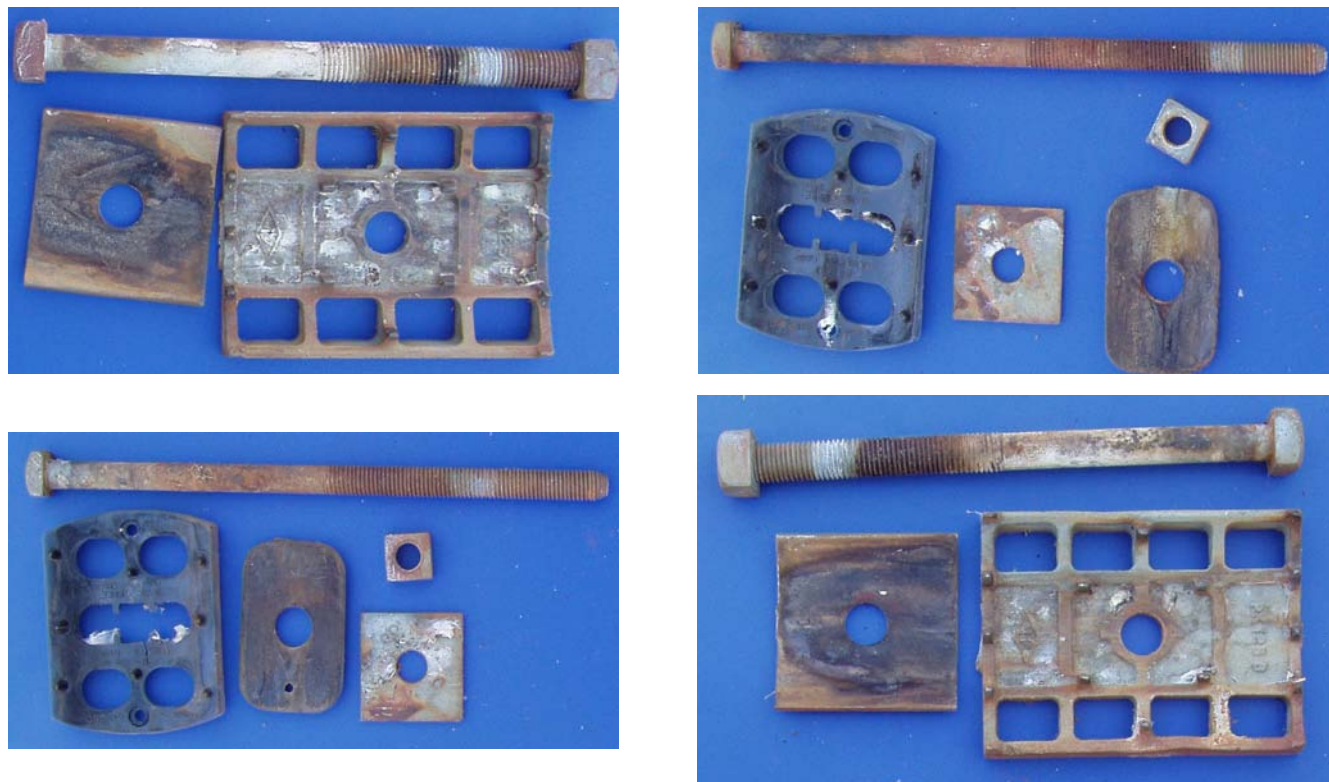
Figure II-4. Condition of nuts, bolts and gain plates removed from field drilled bolts holes after 32 years when no supplemental treatment was applied.

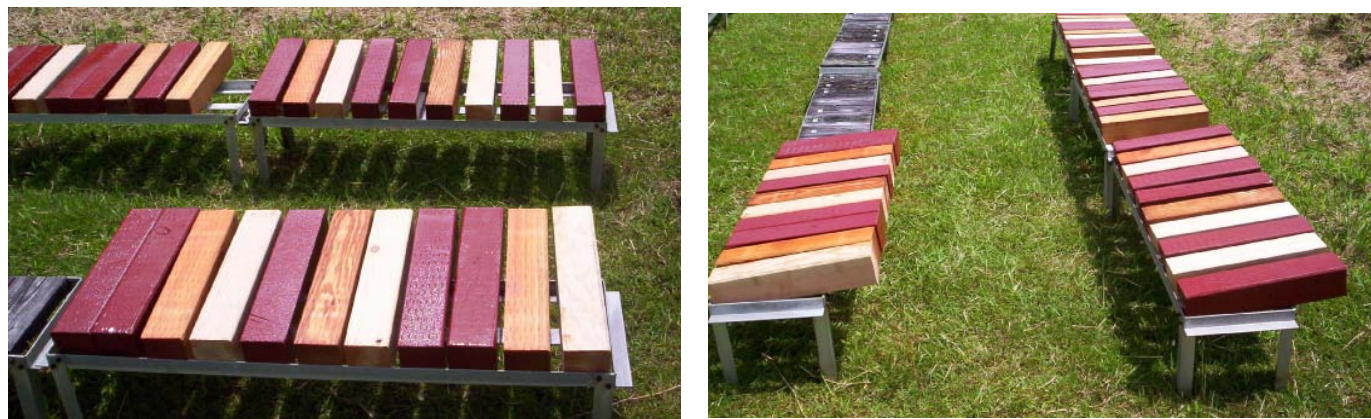
Figure III-1. Examples of Douglas-fir crossarm sections with and without polyurea coating immediately after exposure near Hilo, Hawaii.

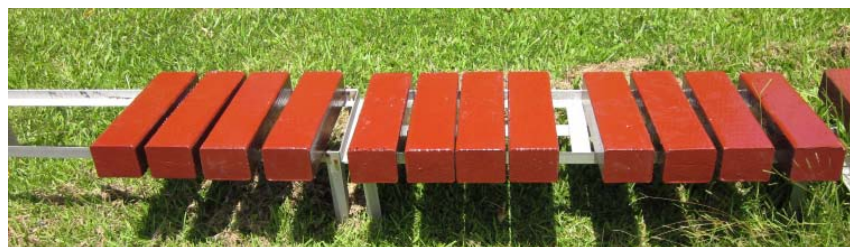
Figure III-2. Polyurea coated Douglas-fir crossarm sections exposed in June 2011.

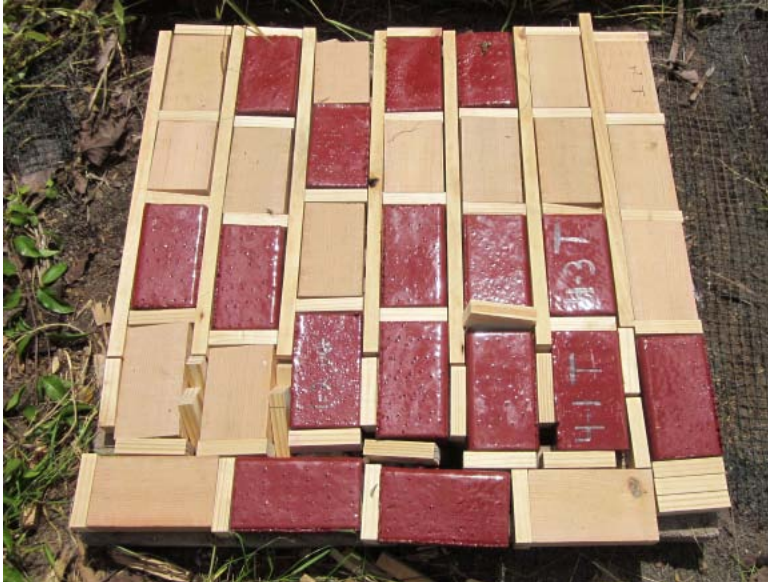
Figure III-3. Example of a termite array containing non-coated and polyurea coated Douglas-fir lumber sections at the time of exposure.

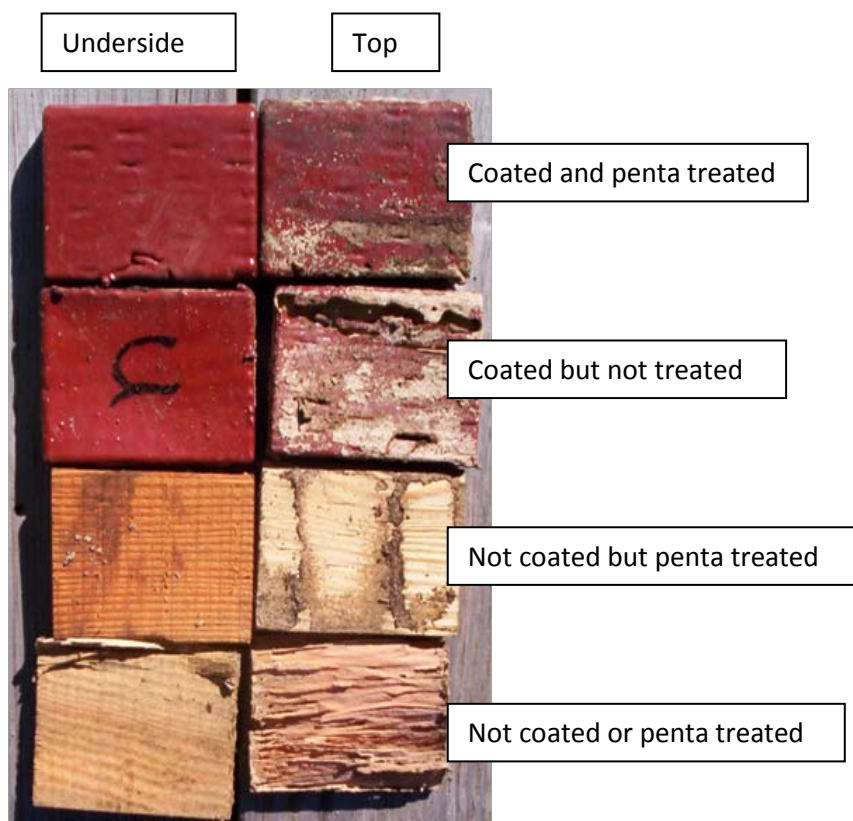
Figure III-4. Examples of undersides (top) and upper surfaces of coated and non-coated Douglas-fir lumber with and without penta treatment.

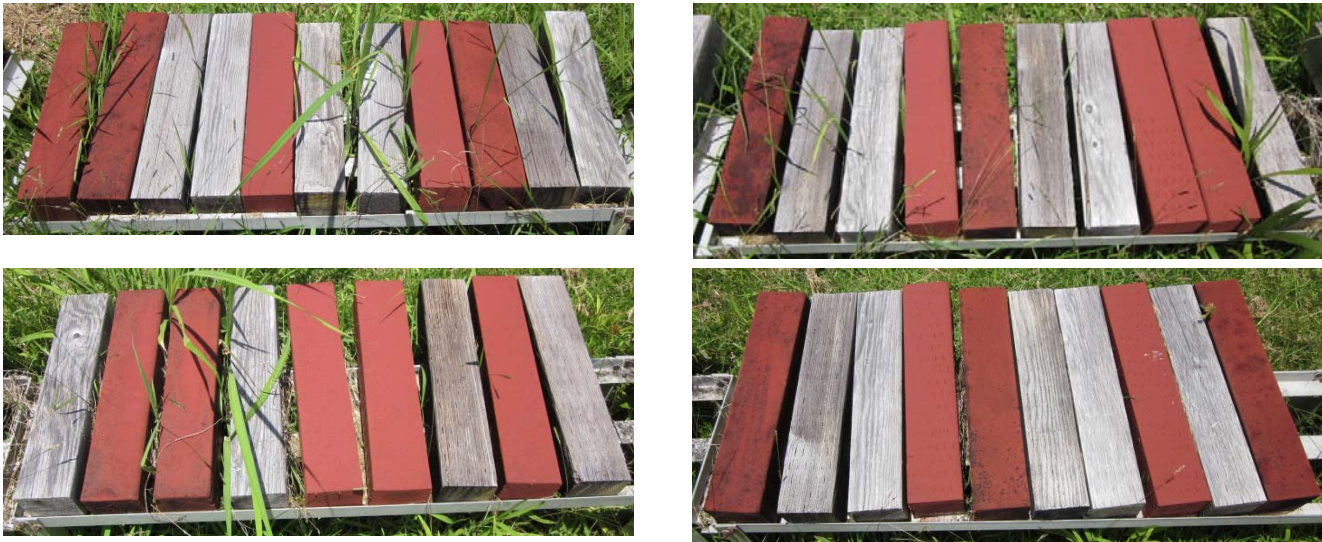
Figure III-5. Examples of the upper (UV exposed) surfaces of coated and non-coated Douglas-fir crossarm sections 18 months after installation at Hilo, Hawaii.

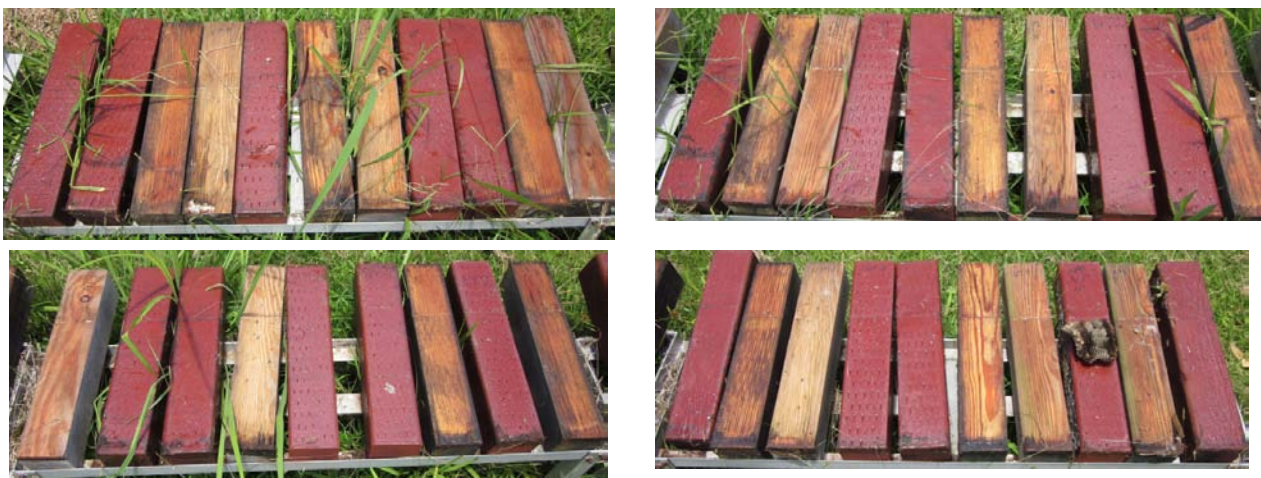
Figure III-6. Examples of the undersides (non-UV exposed) of coated and non-coated Douglas-fir crossarm sections 18 months of exposure in Hilo, Hawaii.

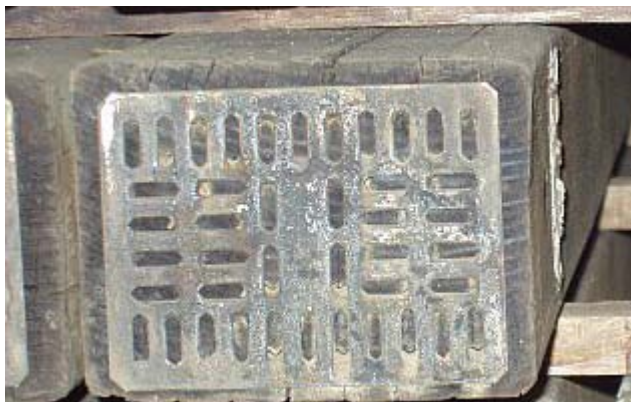
Figure III-7. Example of an end-plate on a penta treated Douglas-fir crossarm.

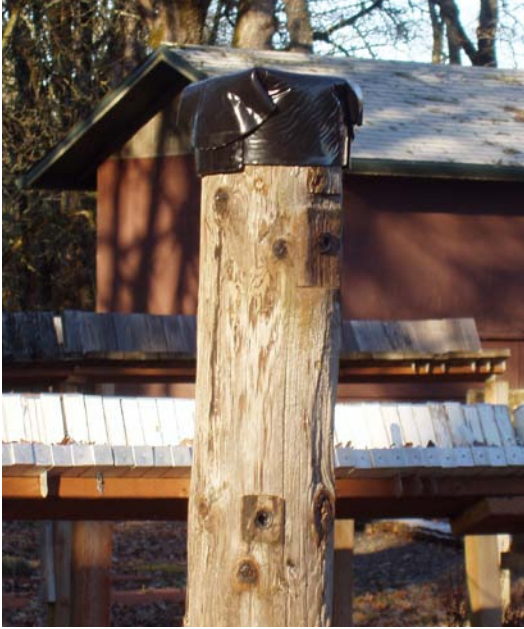
Figure III-8. Example of a capped pole (Osrose Pole Topper) used to assess the effects of capping on wood moisture content.

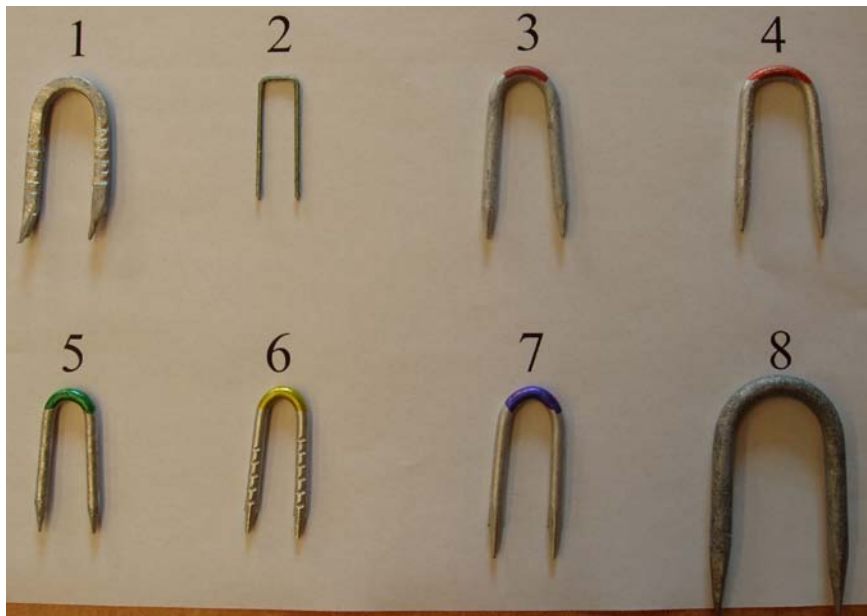
Figure III-9. Examples of ground wire staple types evaluated for withdrawal resistance from penta and ACZA treated Douglas-fir poles.

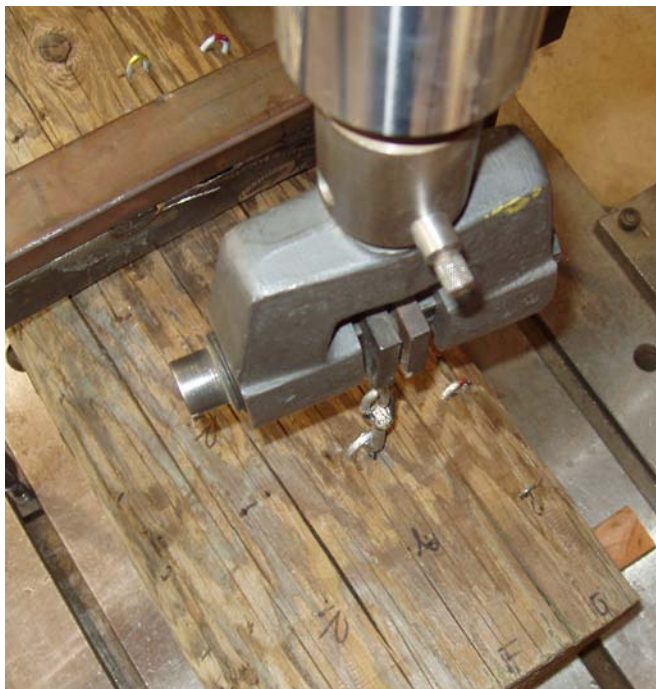
Figure III-10. Example of a ground wire staple being driven into a Douglas-fir pole section.

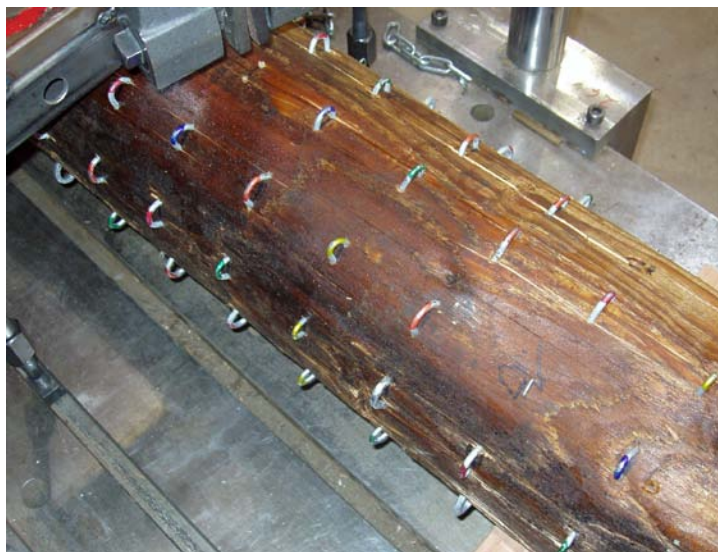
Figure III-11. Example of a pole containing rows of ground wire staples driven into the surface.

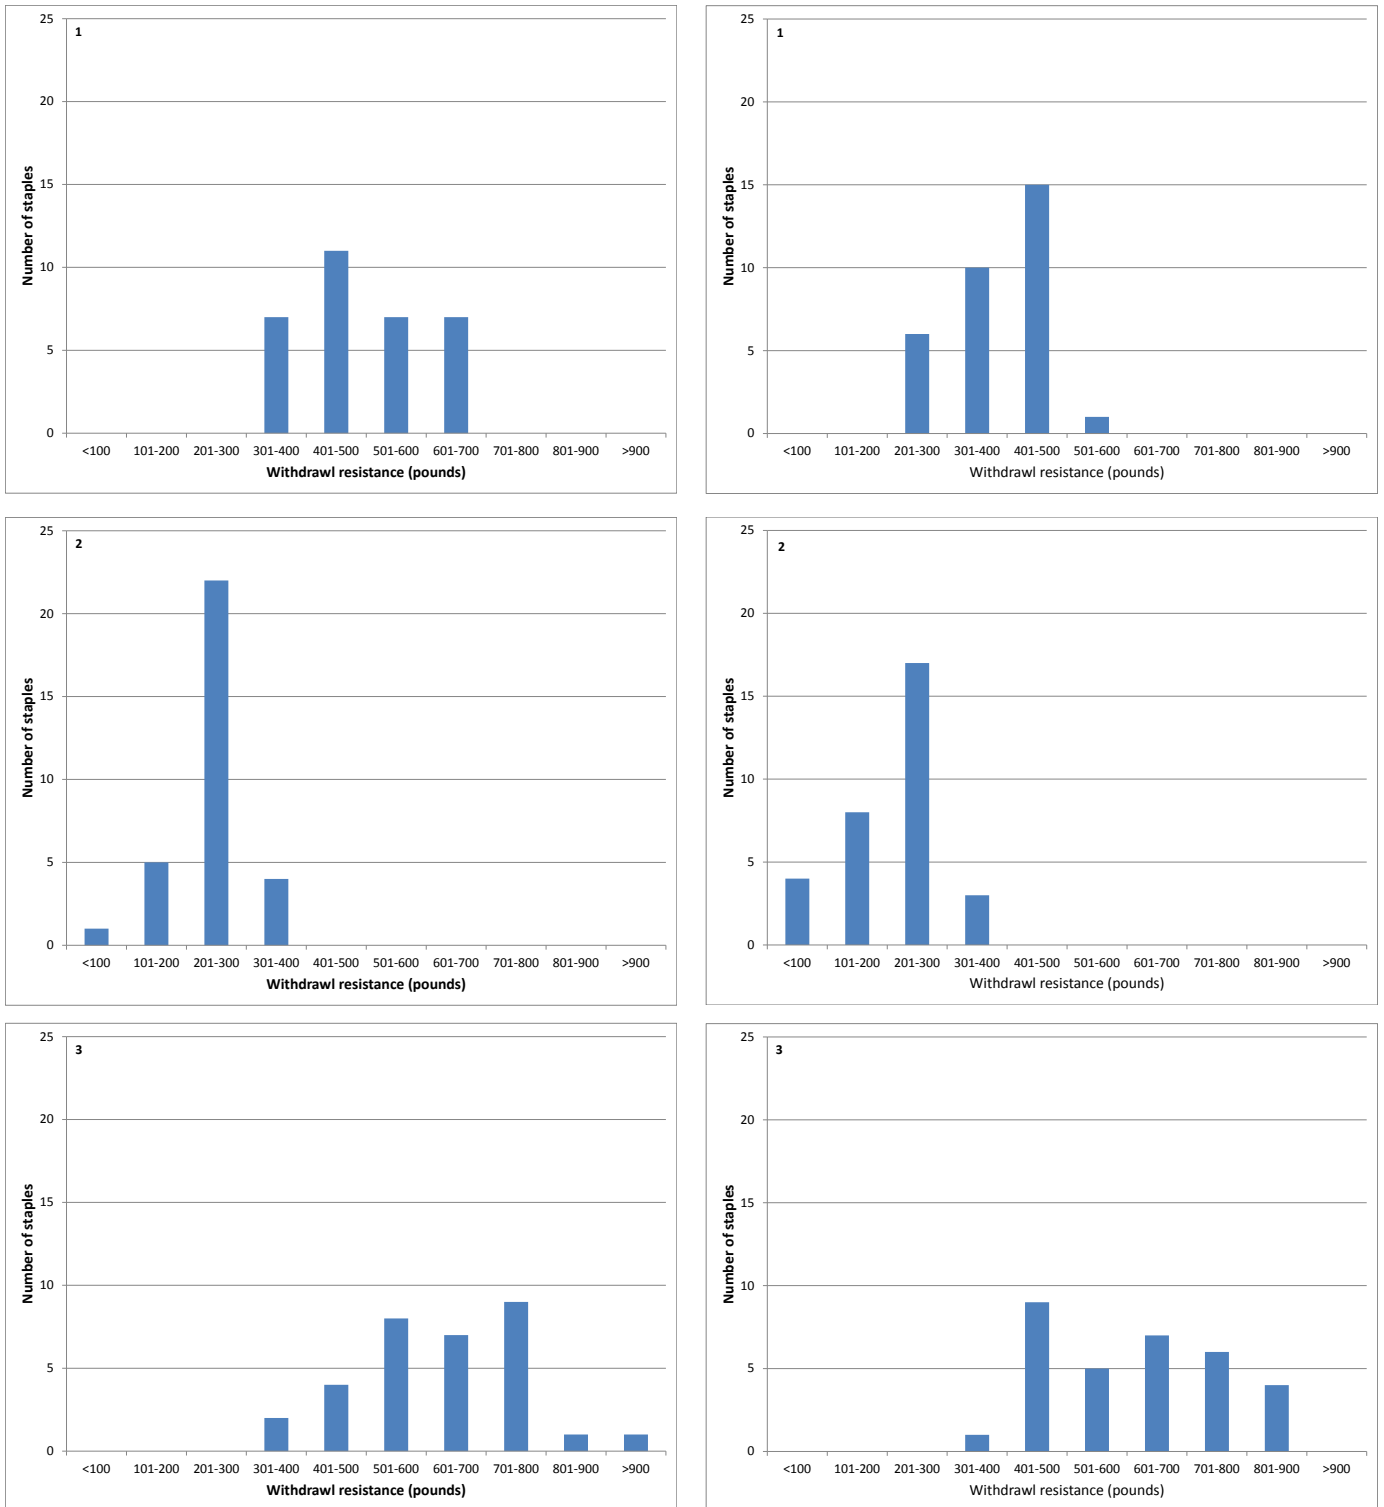
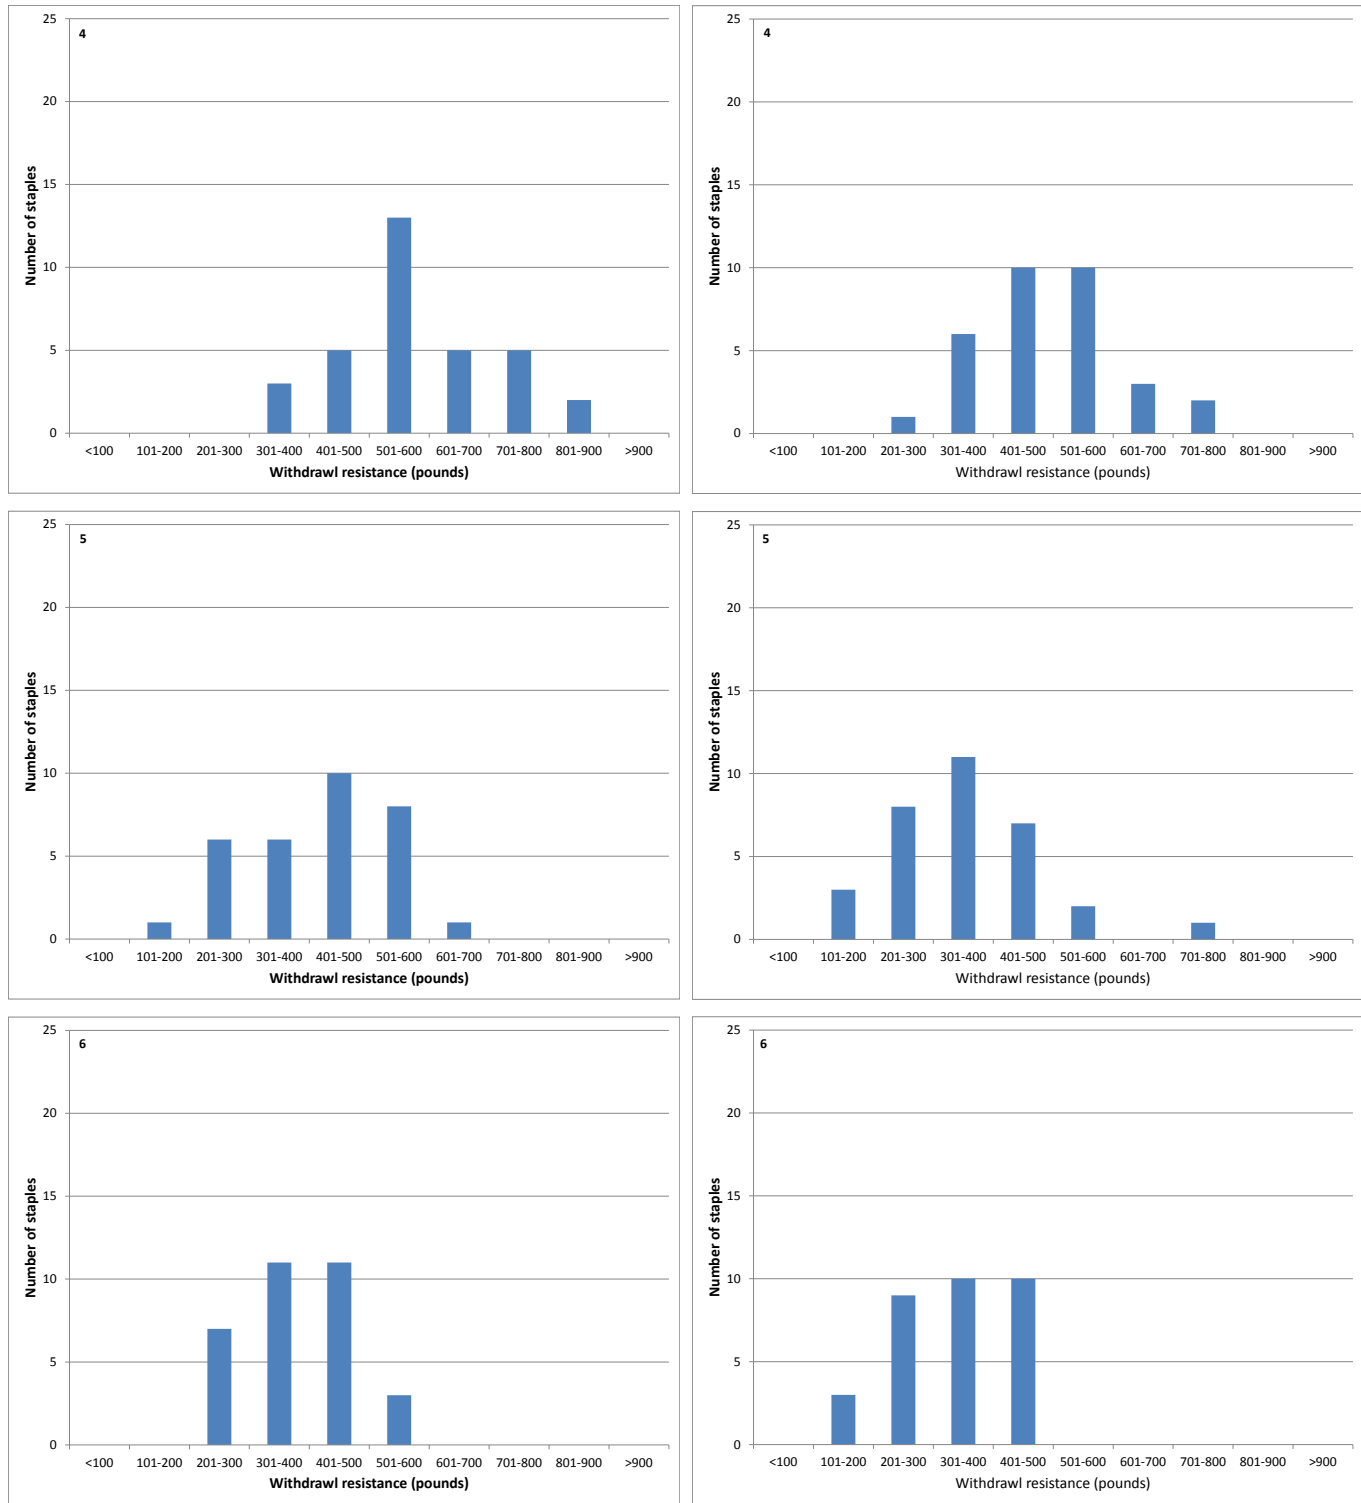
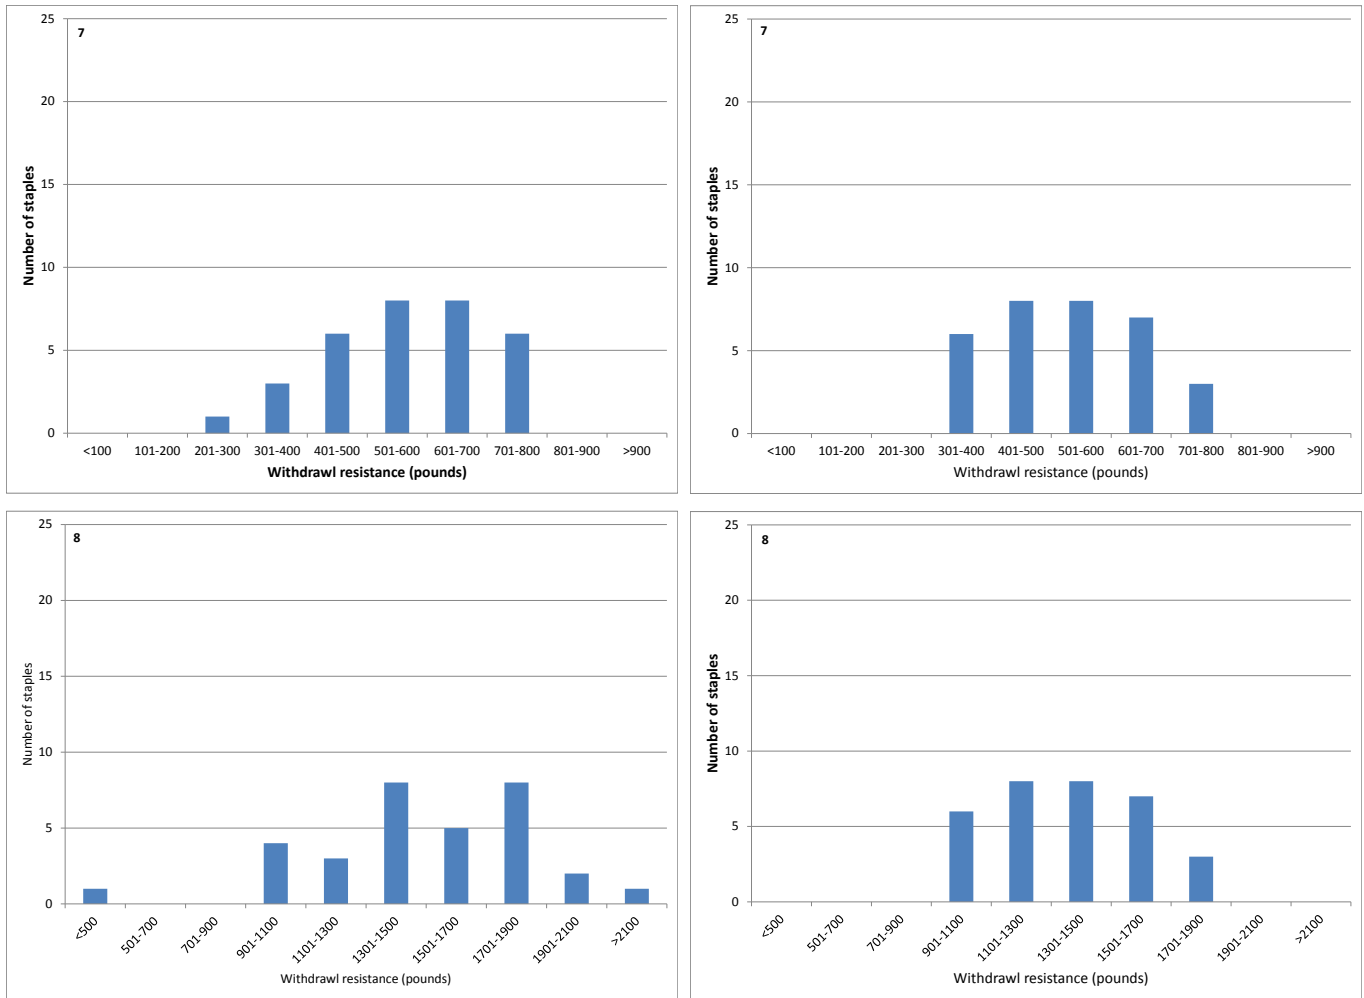
Figure III-13. Histograms showing relative distribution of force required to withdraw ground wire staples from ACZA (left) or penta (right) treated Douglas-fir poles. Thirty-two staples of each type were tested for each pole treatment.

Figure III-13 continued. Histograms showing relative distribution of force required to withdraw ground wire staples from ACZA (left) or penta (right) treated Douglas-fir poles. Thirty-two staples of each type were tested for each pole treatment.

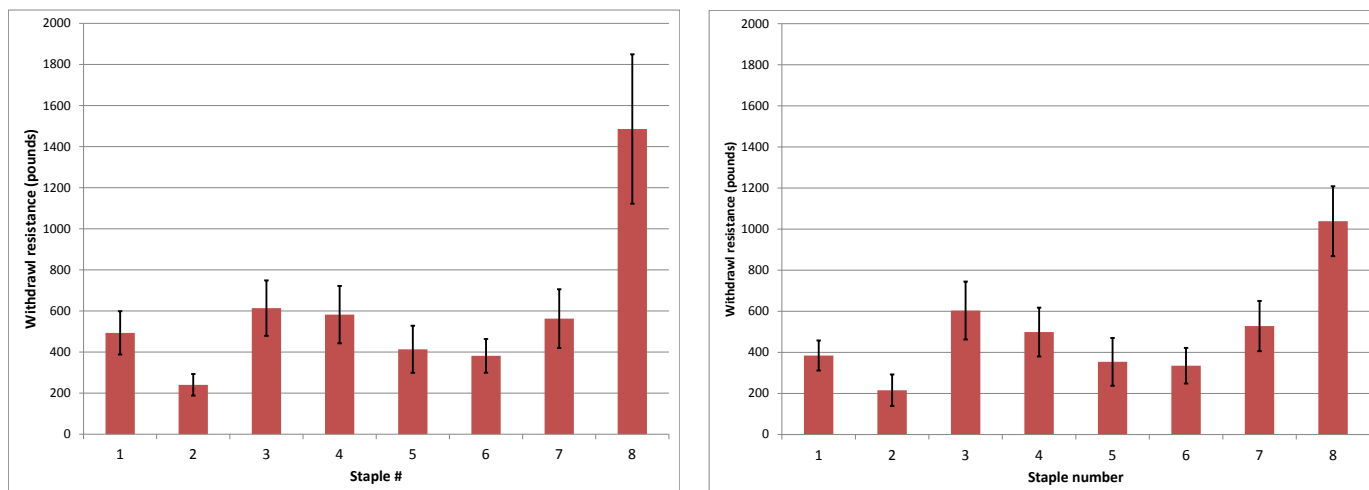
Figure III-14 Average force required to withdraw ground wire staples from ACZA (left) or penta (right) treated Douglas-fir poles. The error bars represent one standard deviation from the mean of thirty-two staples for each pole treatment.

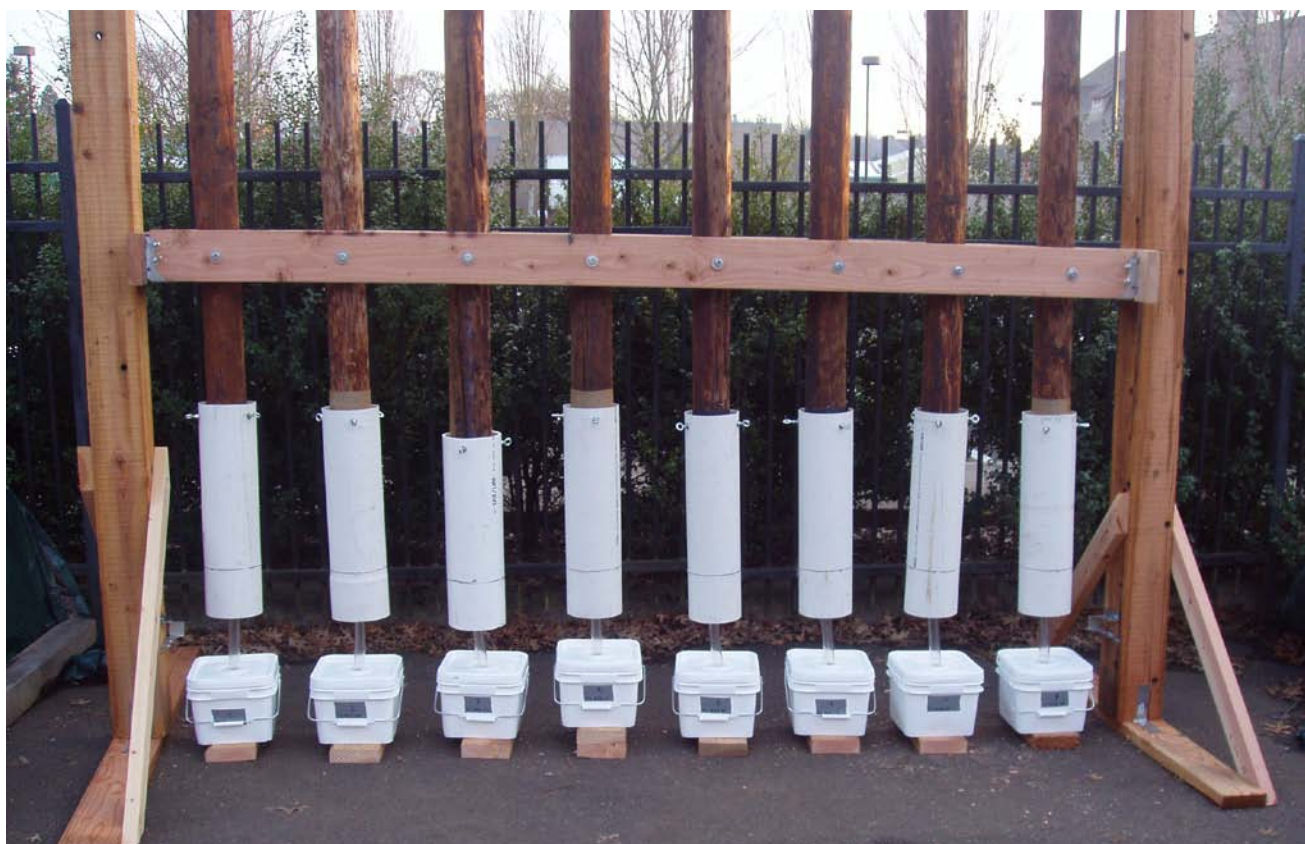
Figure IV-1. Post sections treated with groundline paste showing the plastic containment tubes and the containers used to capture runoff.

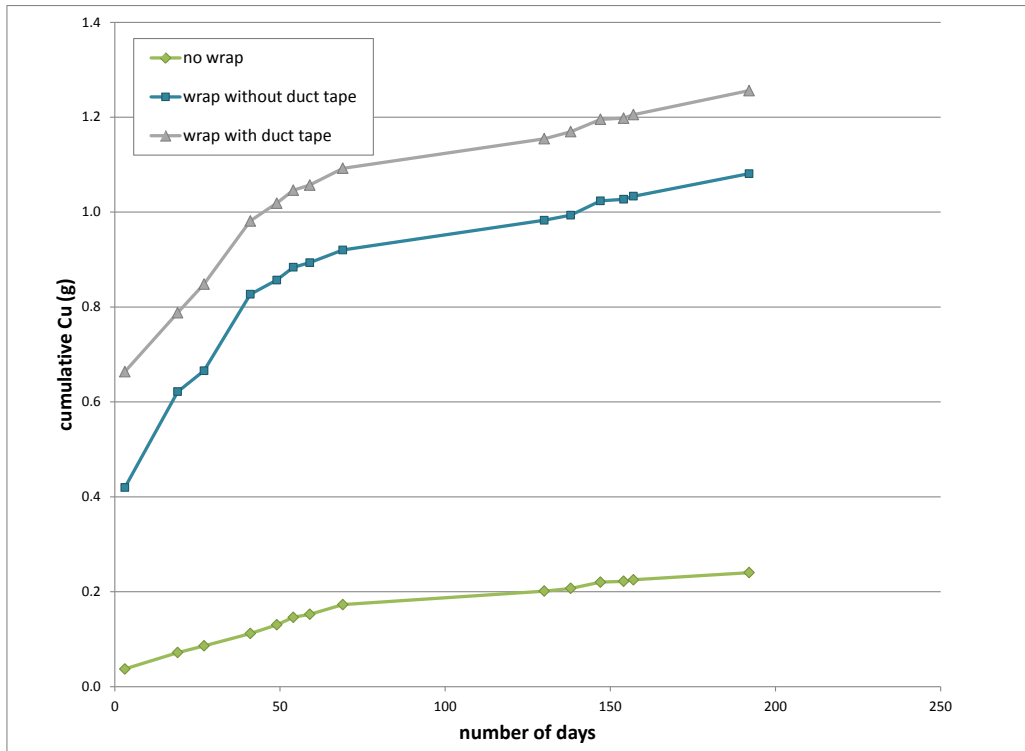
Figure IV-2. Cumulative copper levels in rainwater runoff from the butts of pentachlorophenol treated Douglas-fir pole sections treated with a copper naphthenate/boron paste with or without a duct tape seal at the bottom of the wrap.

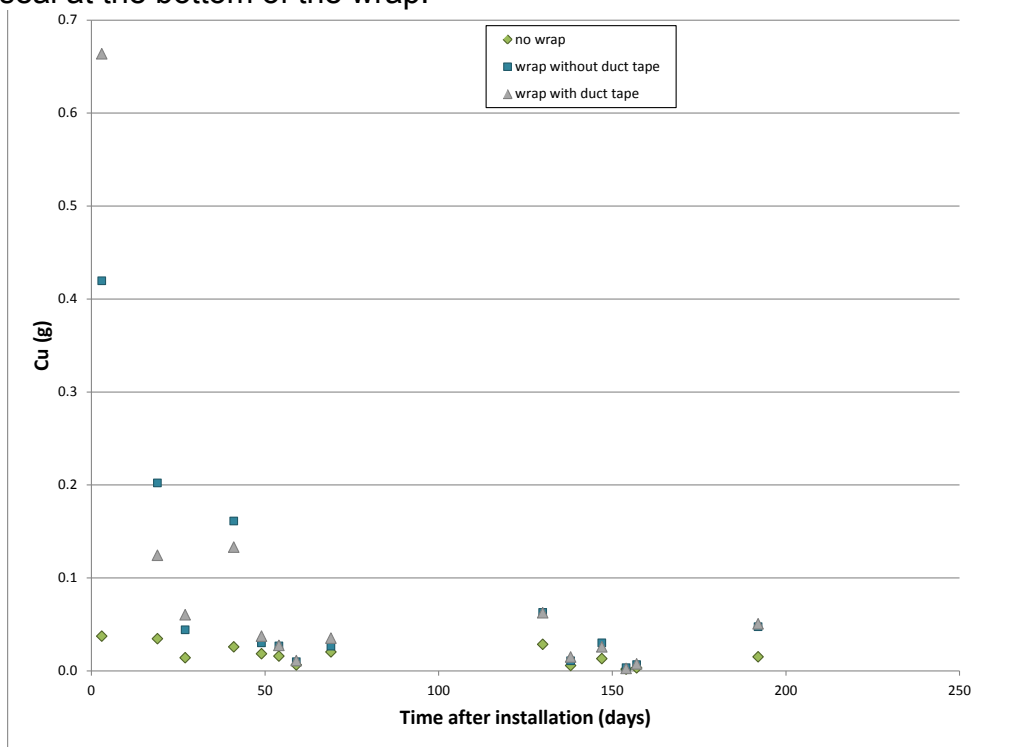
Figure IV-3. Copper levels at each time point in rainwater runoff from the butts of pentachlorophenol treated Douglas-fir pole sections treated with a copper naphthenate/boron paste with or without a duct tape seal at the bottom of the wrap.

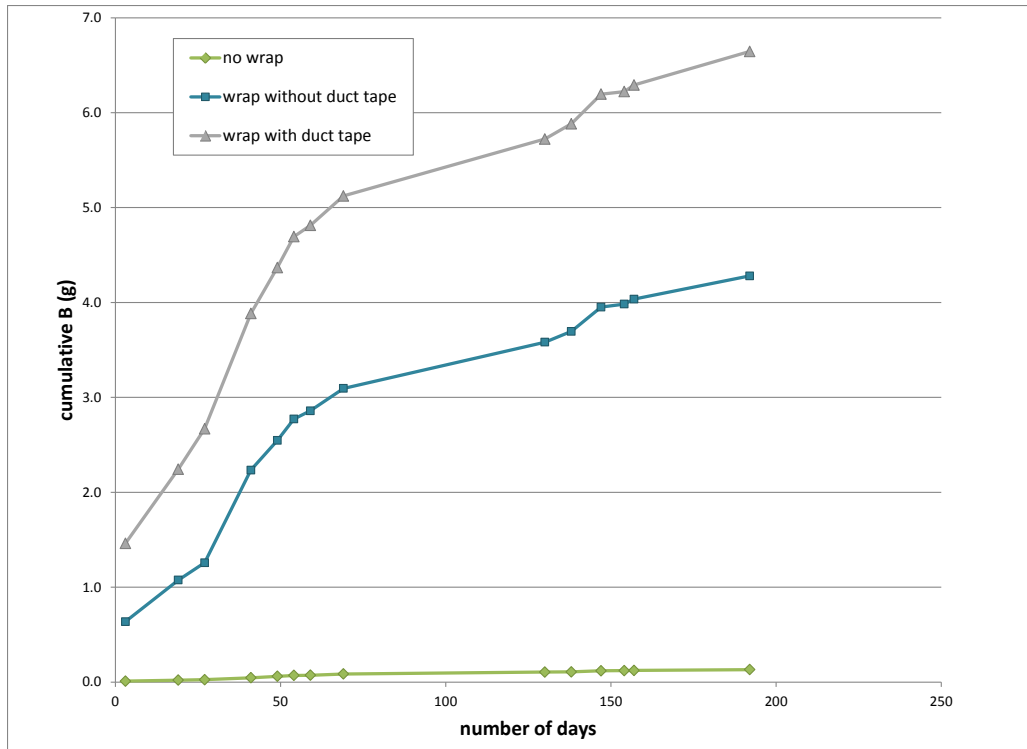
Figure IV-4. Cumulative boron levels in rainwater runoff from the butts of pentachlorophenol treated Douglas-fir pole sections treated with a copper naphthenate/boron paste with or without a duct tape seal at the top of the wrap.

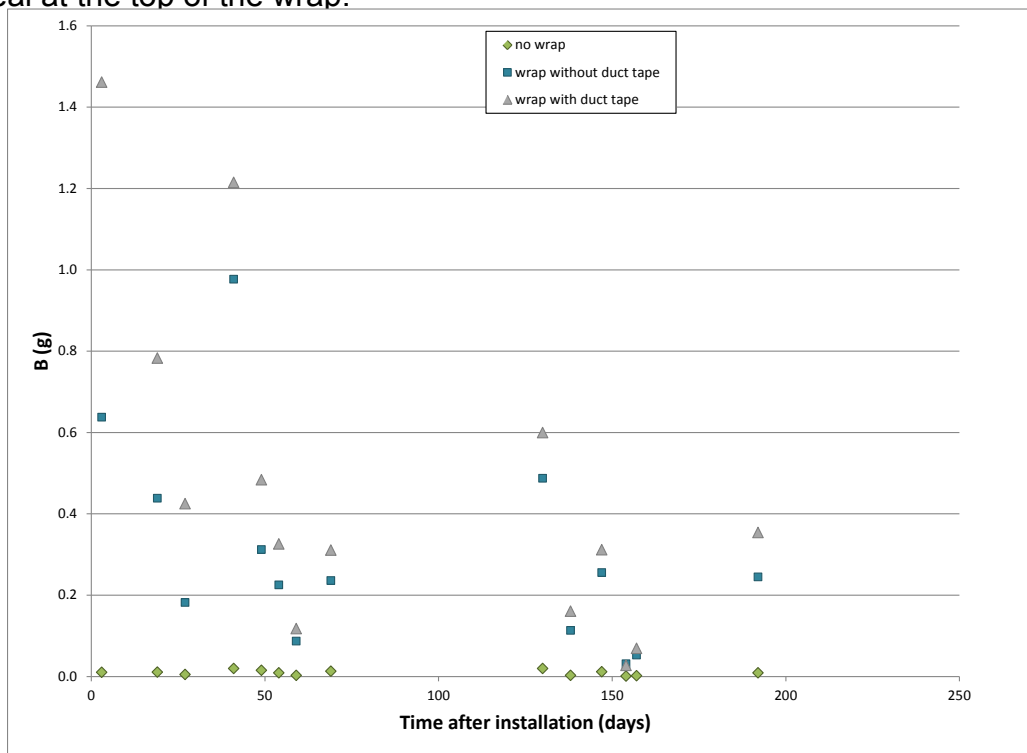
Figure IV-5. Boron levels at each time point in rainwater runoff from the butts of pentachlorophenol treated Douglas-fir pole sections treated with a copper naphthenate/boron paste with or without a duct tape seal at the bottom of the wrap.

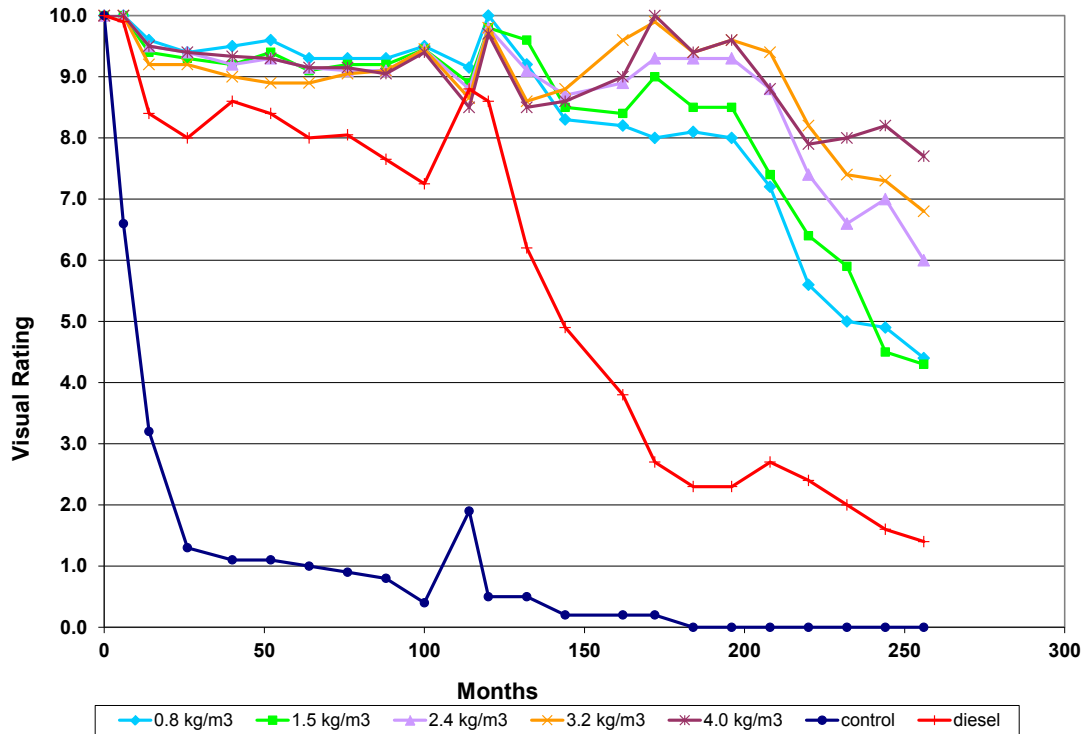
Figure V-1. Condition of freshly sawn western redcedar sapwood stakes treated with selected retentions of copper naphthenate in diesel oil and exposed in a soil bed for 256 months.

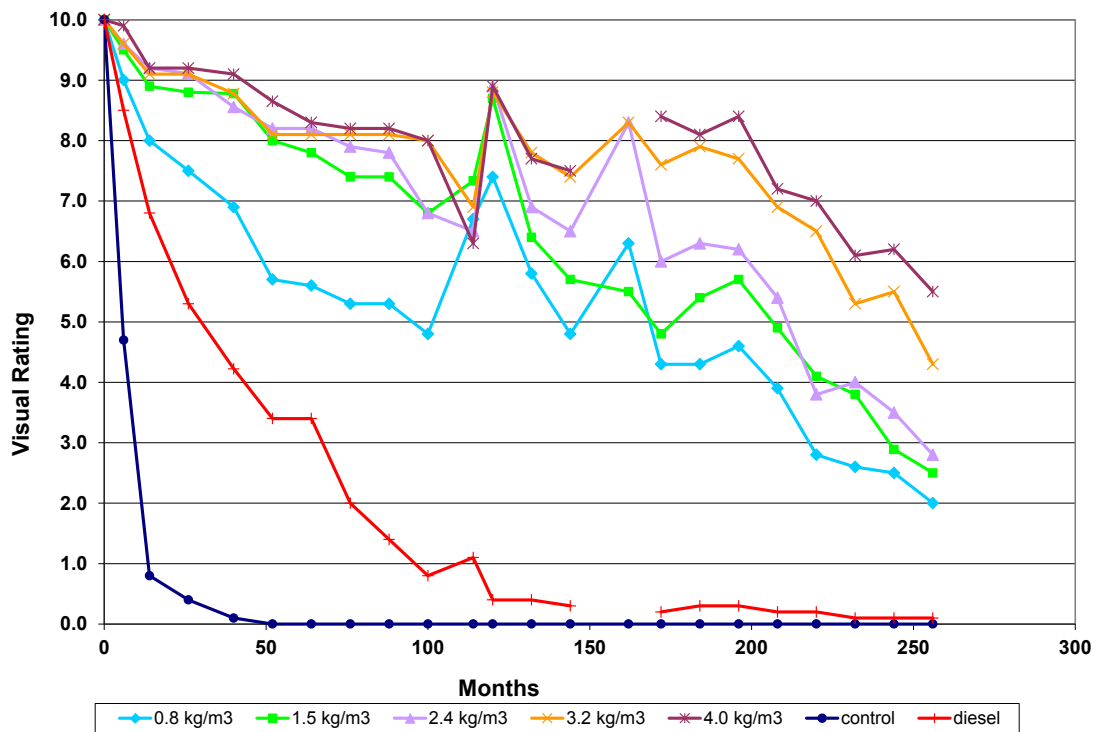
Figure V-2. Condition of weathered western redcedar sapwood stakes treated with selected retentions of copper naphthenate in diesel oil and exposed in a soil bed for 256 months.

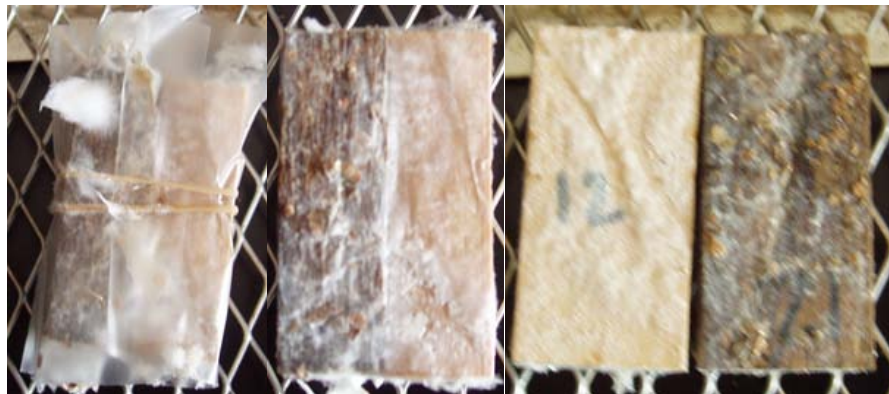
Figure V-3. Examples of Douglas-fir block assemblies used to evaluate the potential for *P. placenta* to move from the heartwood to copper naphthenate treated sapwood where A) 2 blocks wrapped in plastic, B) the blocks outside the wrap and C) the sapwood/heartwood (left/right) blocks side by side.
