# Oregon State University Utility Pole Research Cooperative

31st Annual Report  
October 3<sup>rd</sup> 2011

### **DEVELOP SAFER CHEMICALS FOR CONTROLLING INTERNAL DECAY OF WOOD POLES**

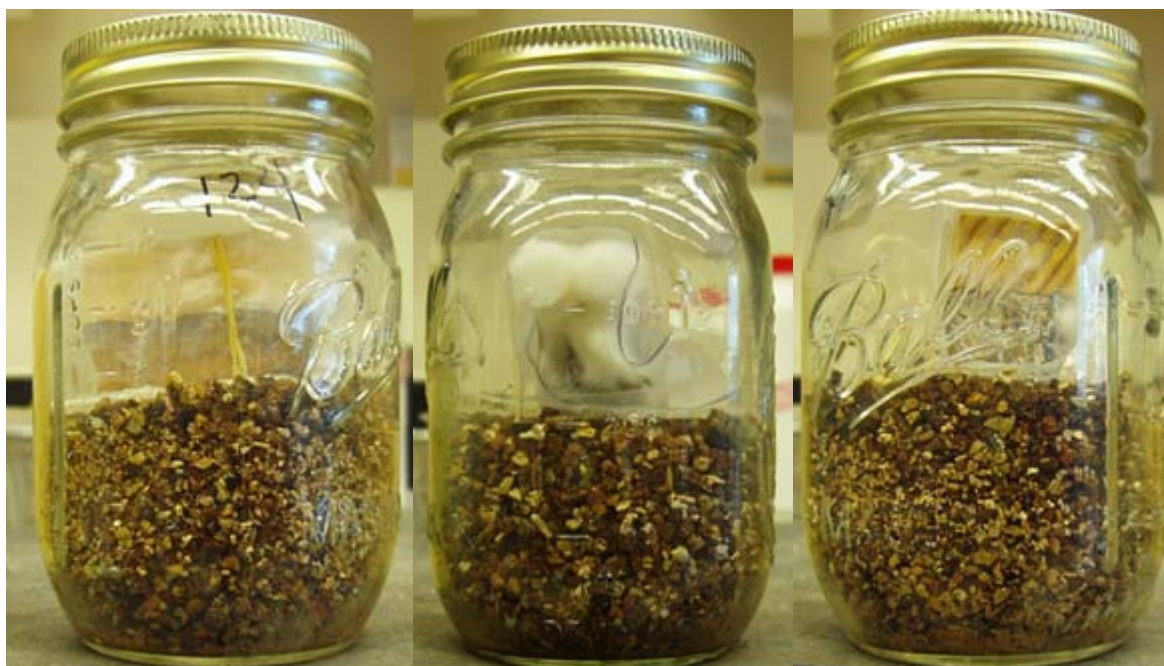
Figure V-4. Decay assemblies in glass jars used to assess the potential for *P. placenta* to move from the inoculated Douglas-fir heartwood to copper naphthenate treated Douglas-fir sapwood

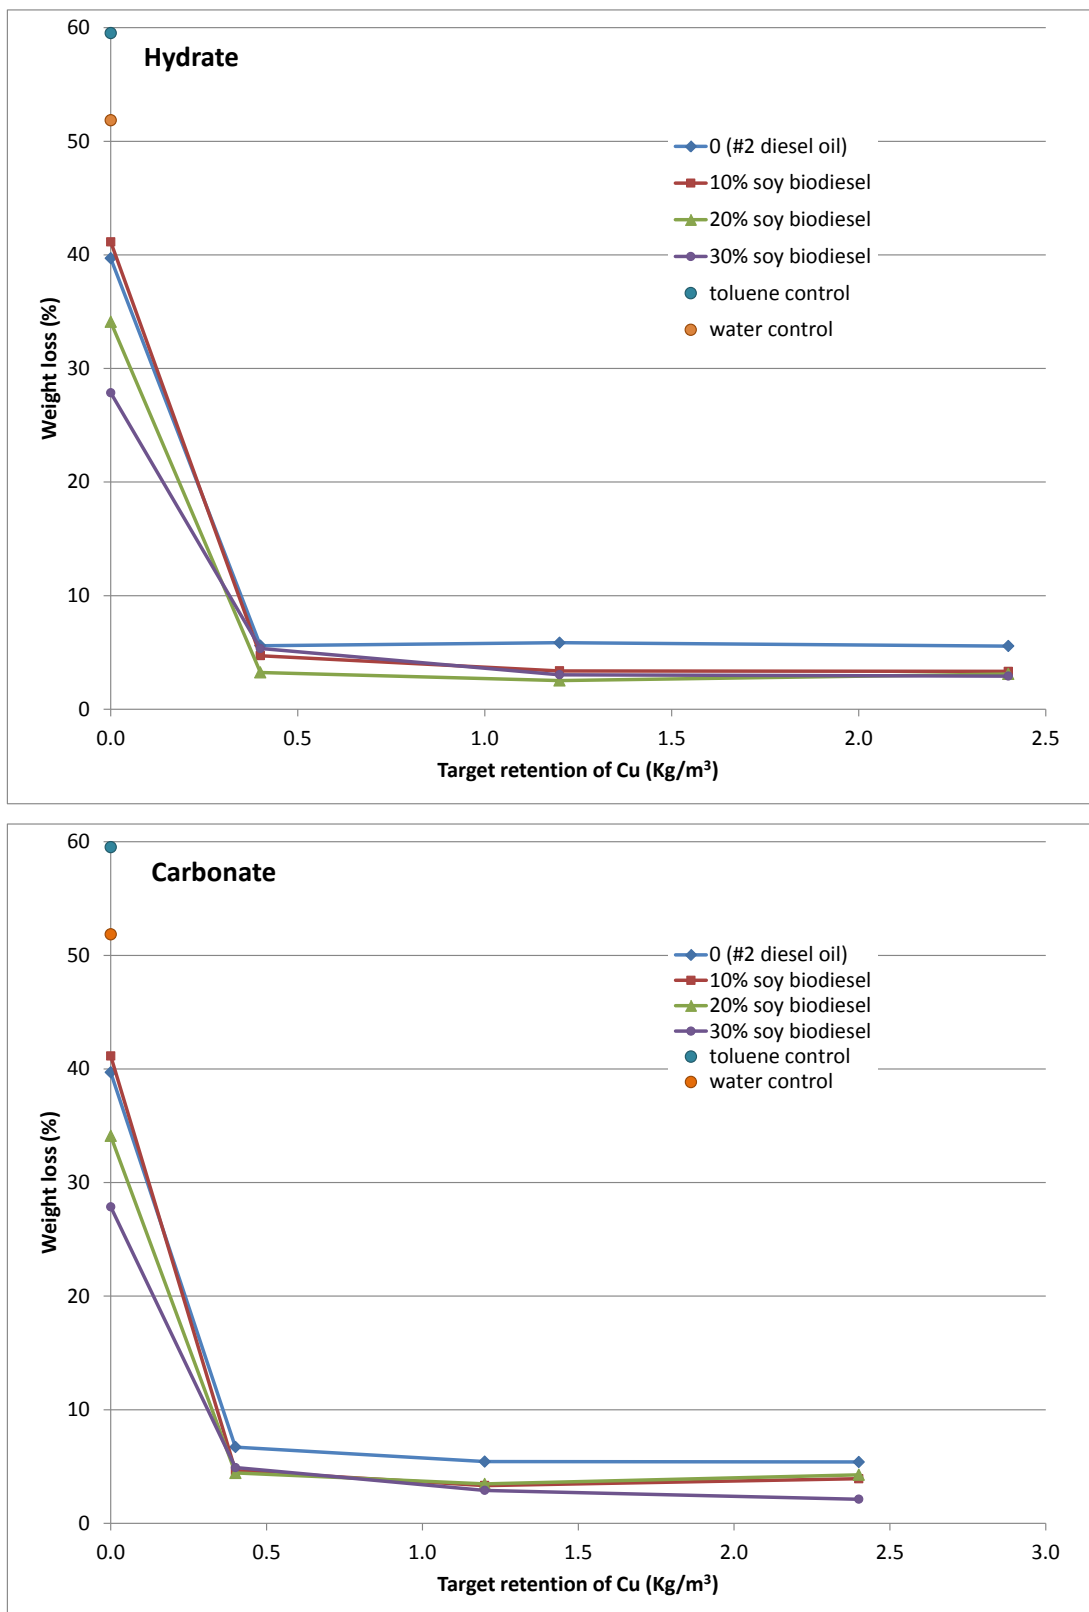
Figure V-5. Effect of copper naphthenate source (hydrate or carbonate) and the presence of different levels of a soy-based biodiesel co-solvent on resistance of non-weathered southern pine sapwood blocks exposed to *G. trabeum* in an AWPA E10 soil block test.

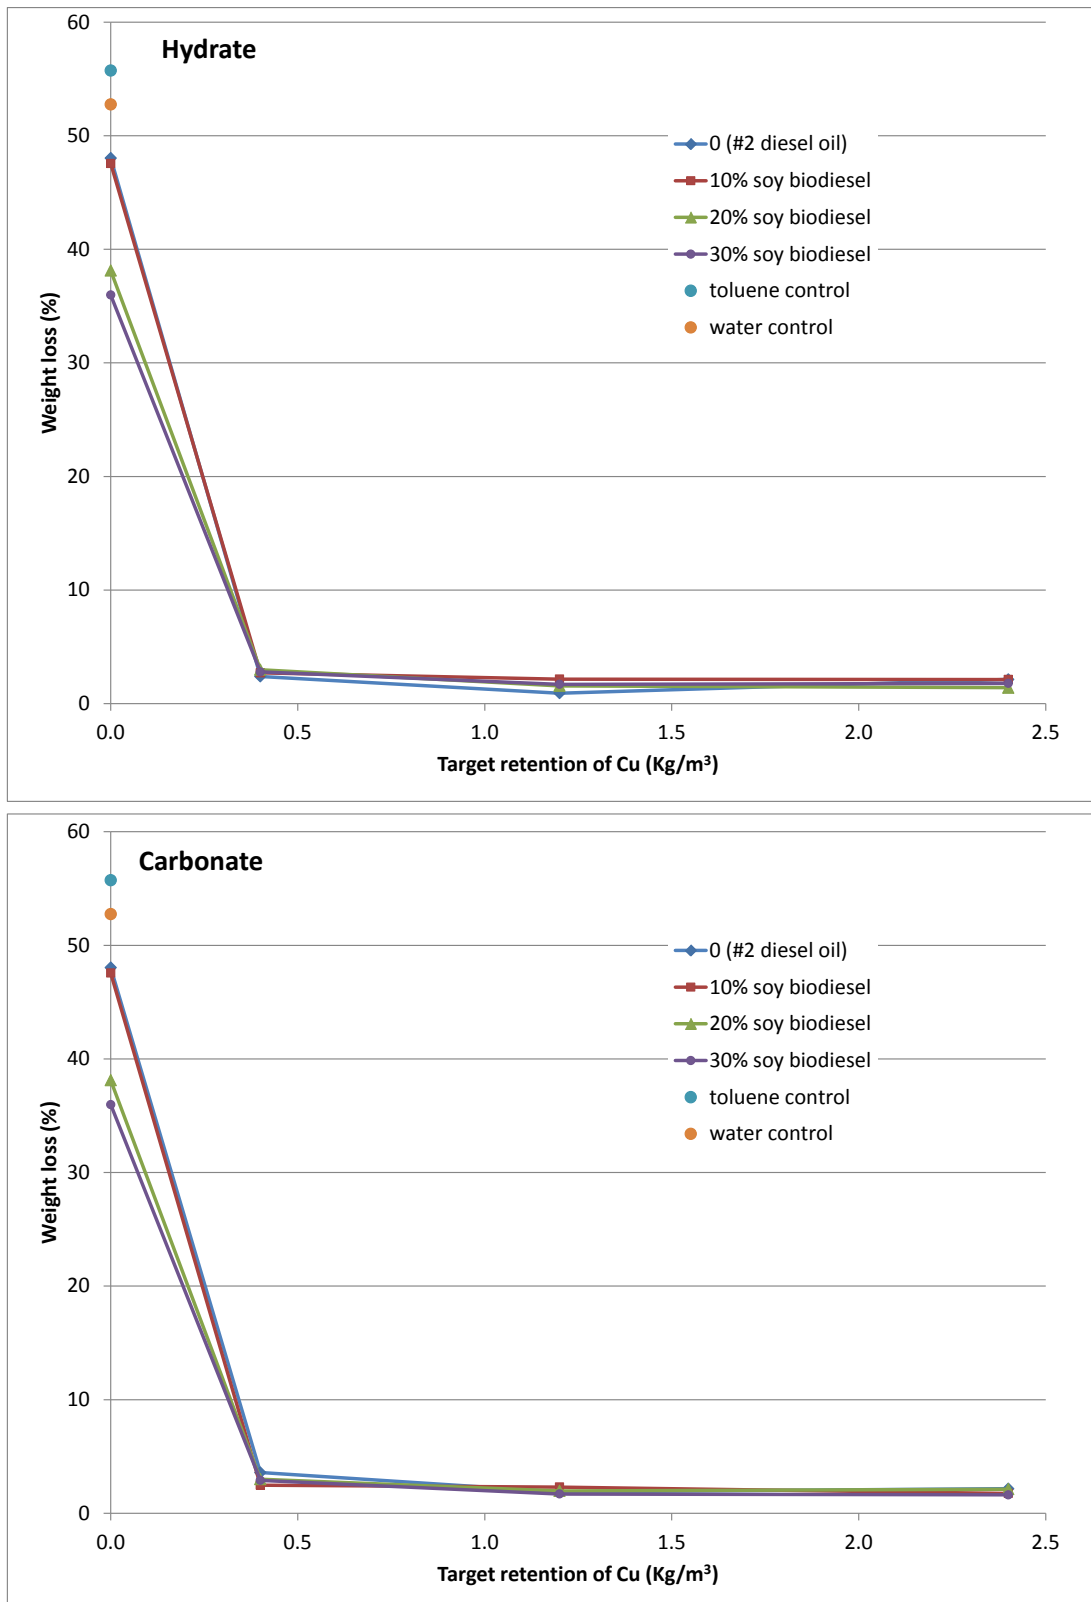
Figure V-6. Effect of copper naphthenate source (hydrate or carbonate) and the presence of different levels of a soy-based biodiesel co-solvent on resistance of weathered southern pine sapwood blocks exposed to *G. trabeum* in an AWPA E10 soil block test.

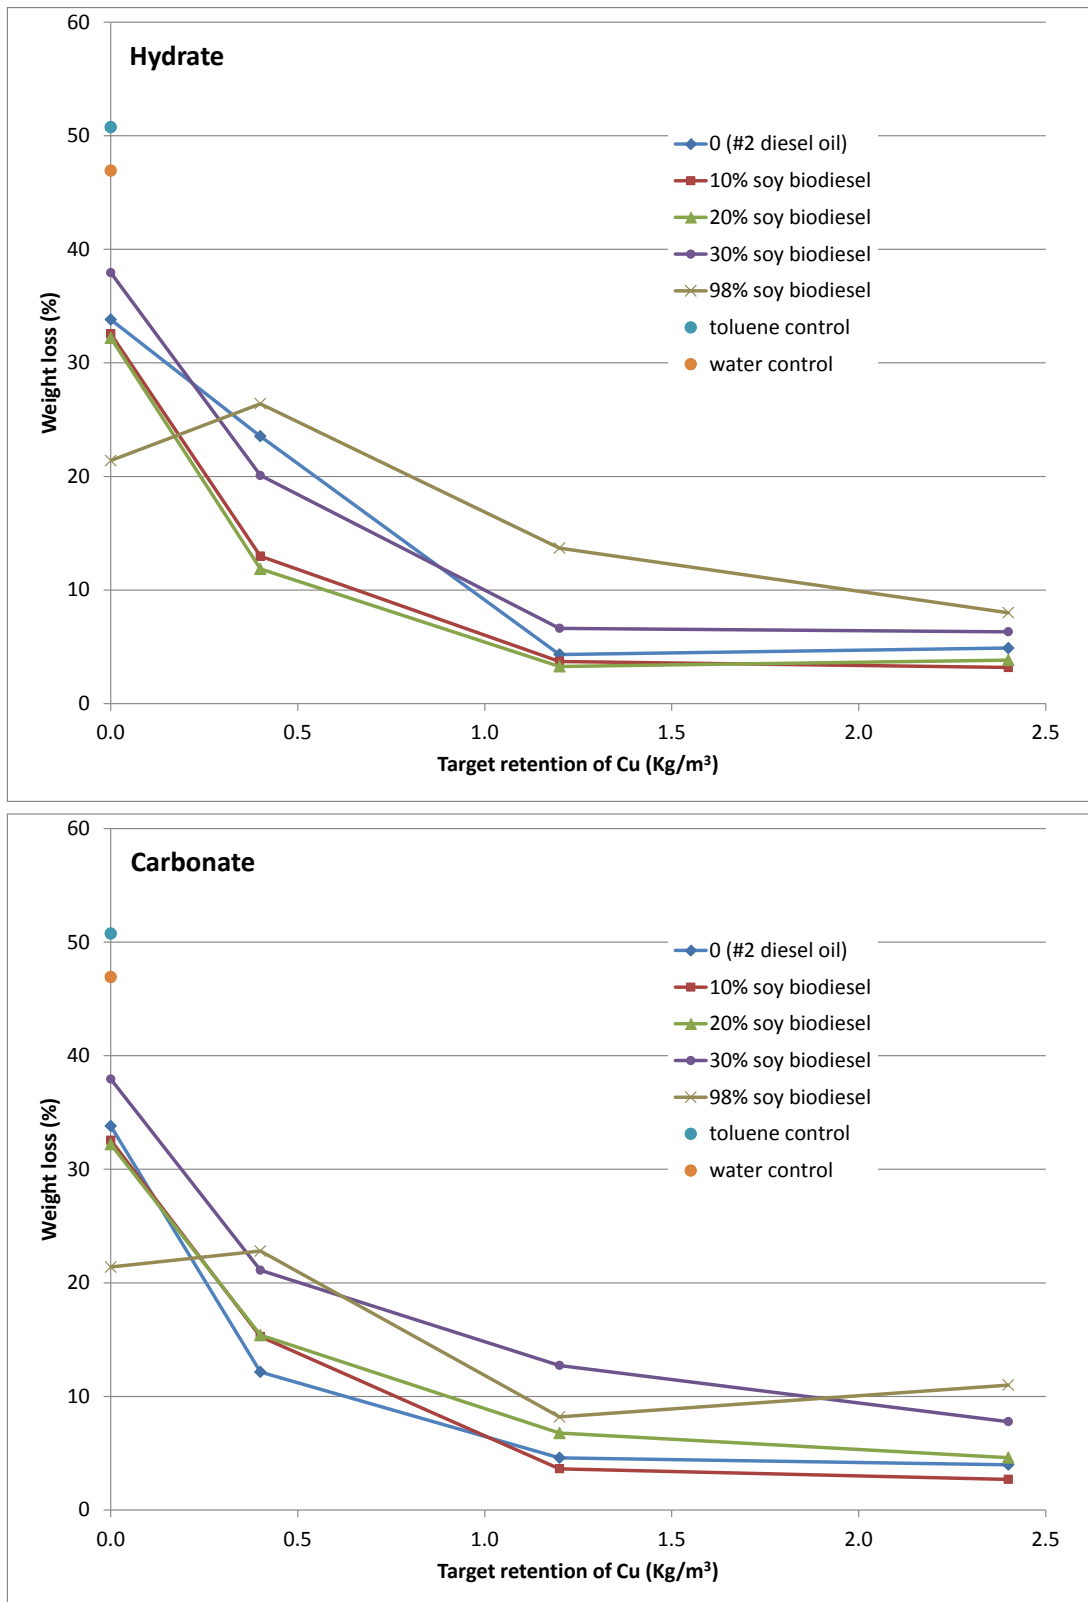
Figure V-7. Effect of copper naphthenate source and the presence of different levels of a soy-based biodiesel co-solvent on resistance of non-weathered southern pine sapwood blocks exposed to *P. placentae* in an AWP A E10 soil block test.

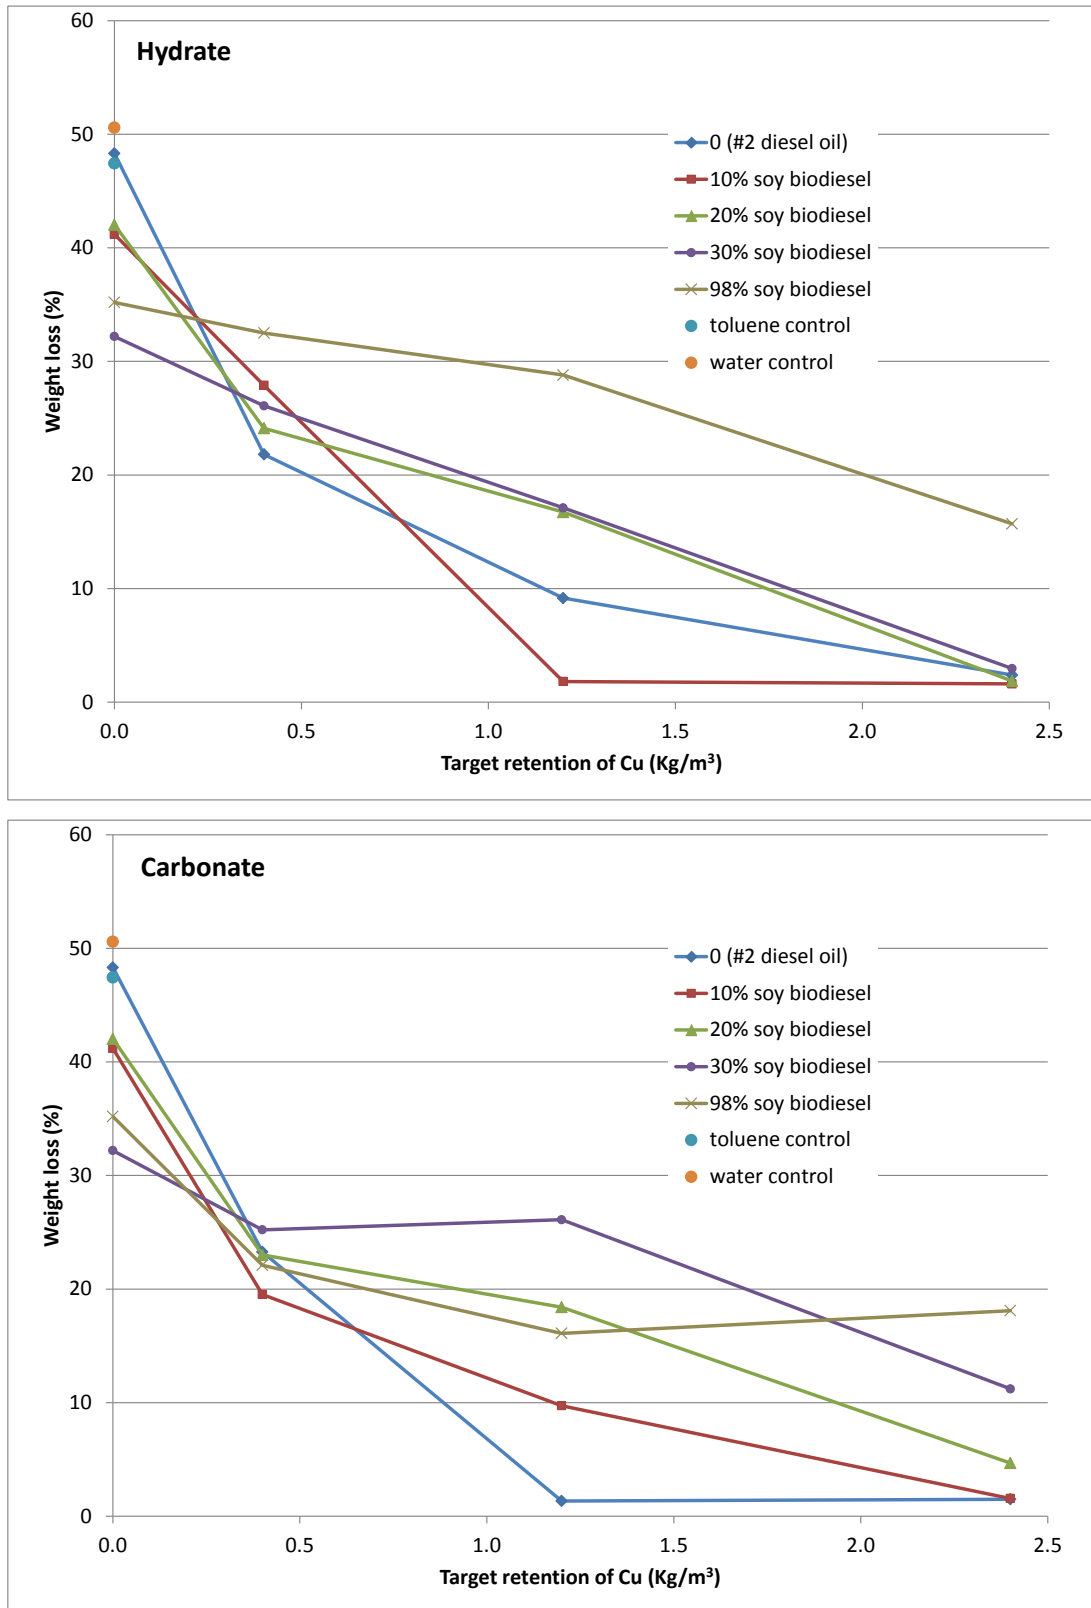
Figure V-8. Effect of copper naphthenate source (hydrate or carbonate) and the presence of different levels of a soy-based biodiesel co-solvent on resistance of weathered southern pine sapwood blocks exposed to *P. placentia* in an AWP A E10 soil block test.

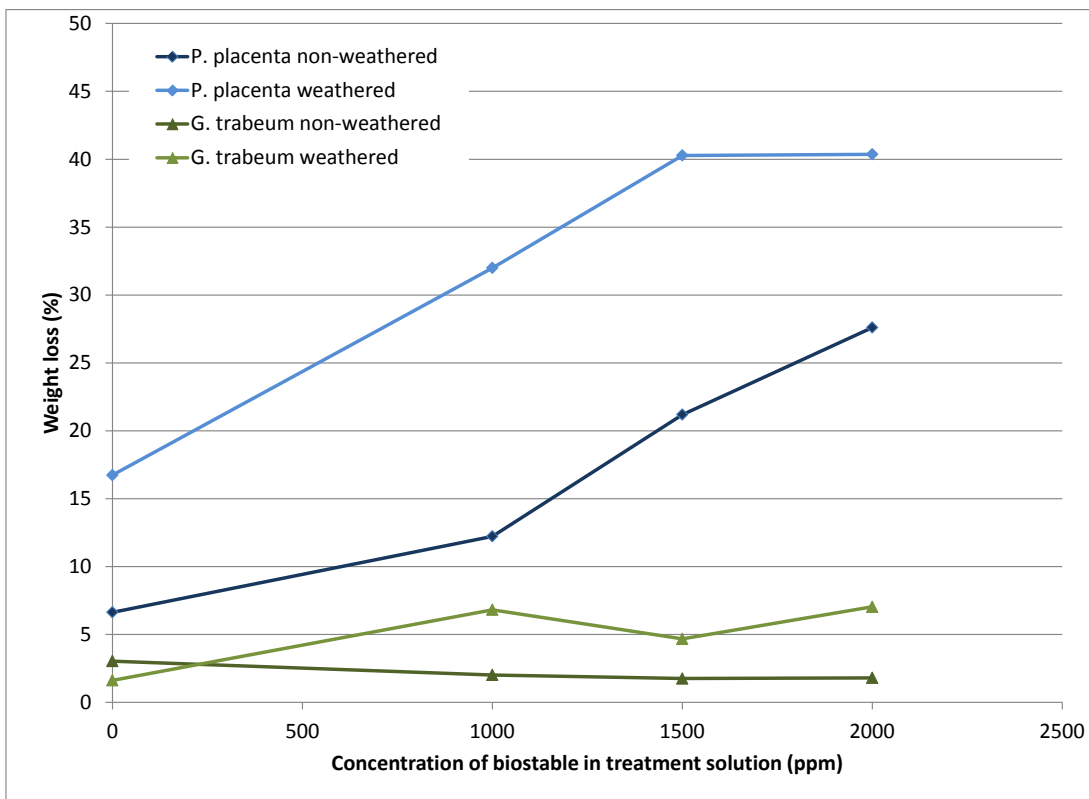
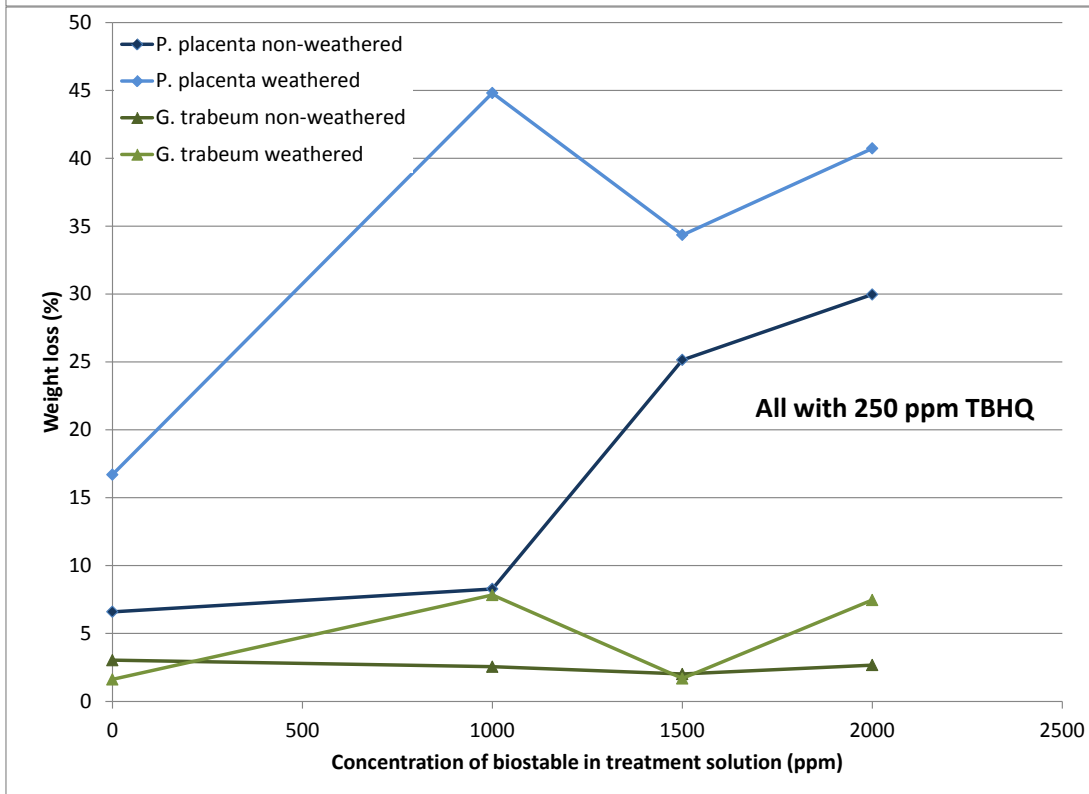
Figure V-9. Effect of biostabilizers A. biostable and B. biostable with 250 ppm TBHQ on performance of copper naphthenate solubilized in #2 diesel amended with 30 % soy-based biodiesel.

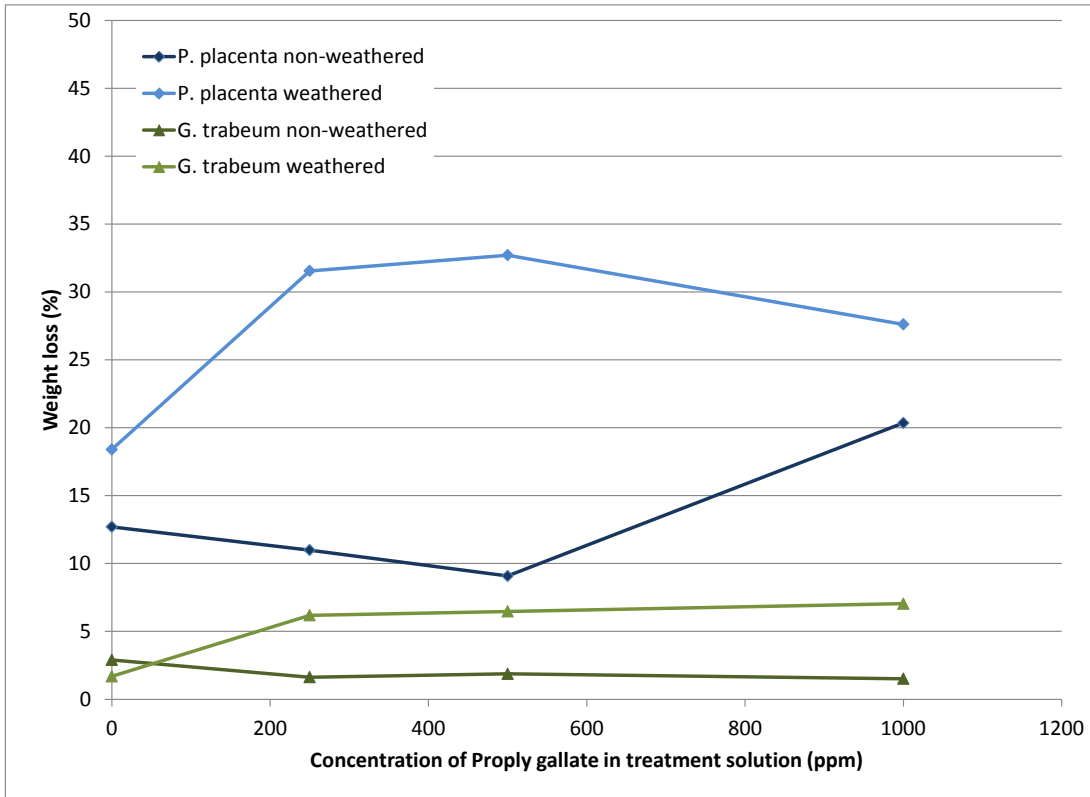
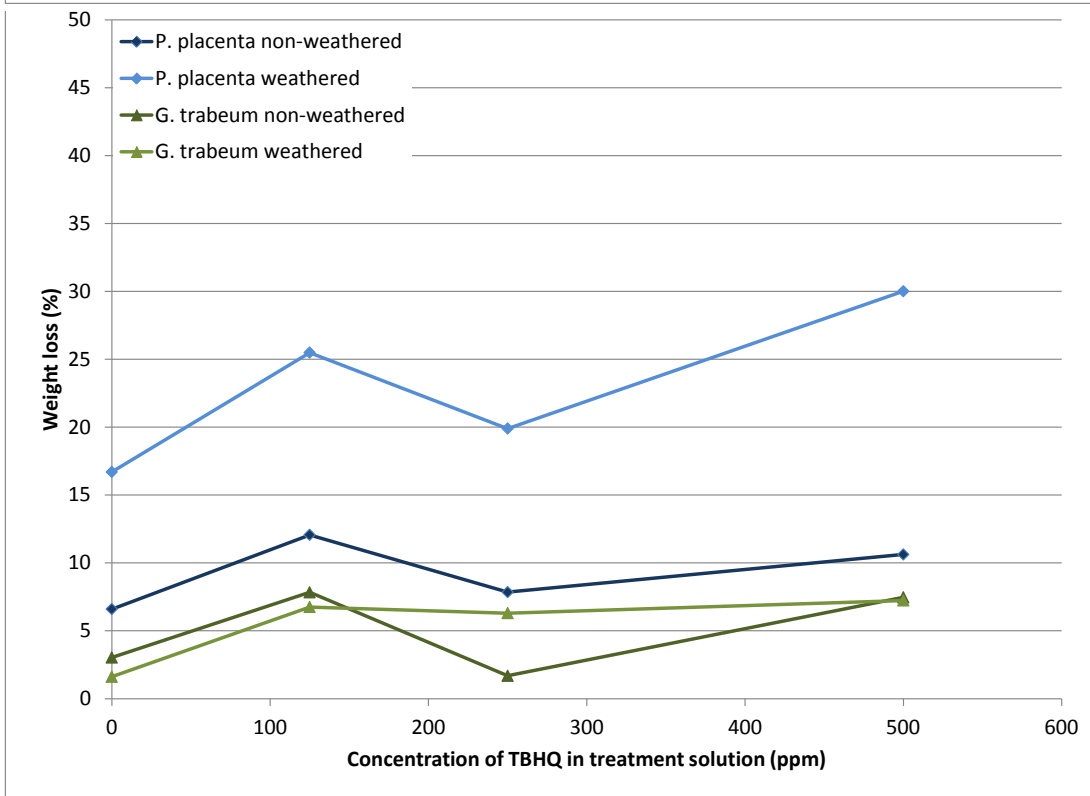
Figure V-9. cont.. Effect of biostabilizers C. propyl gallate and D.TBHQ on performance of copper naphthenate solubilized in #2 diesel amended with 30 % soy-based biodiesel.

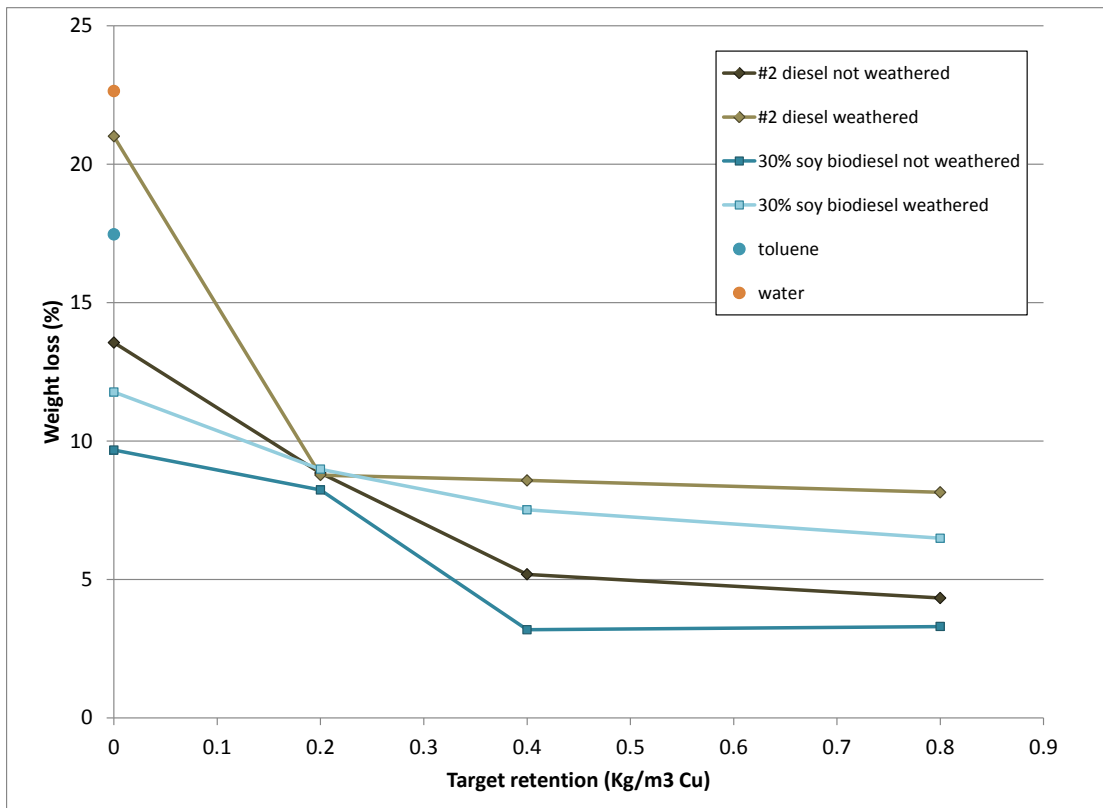
Figure V-10. Weight losses in Douglas-fir sapwood samples treated with copper naphthenate in #2 diesel alone or amended with 30 % biodiesel and exposed to *P. placenta* colonized Douglas-fir heartwood blocks for 20 weeks at room temperature.
